Geotecnia e Ingeniería Sísmica aplicadas a la Minería

LA ROTURA DE LA PRESA DE AZNALCÓLLAR

Eduardo Alonso

Aznalcóllar dam failure

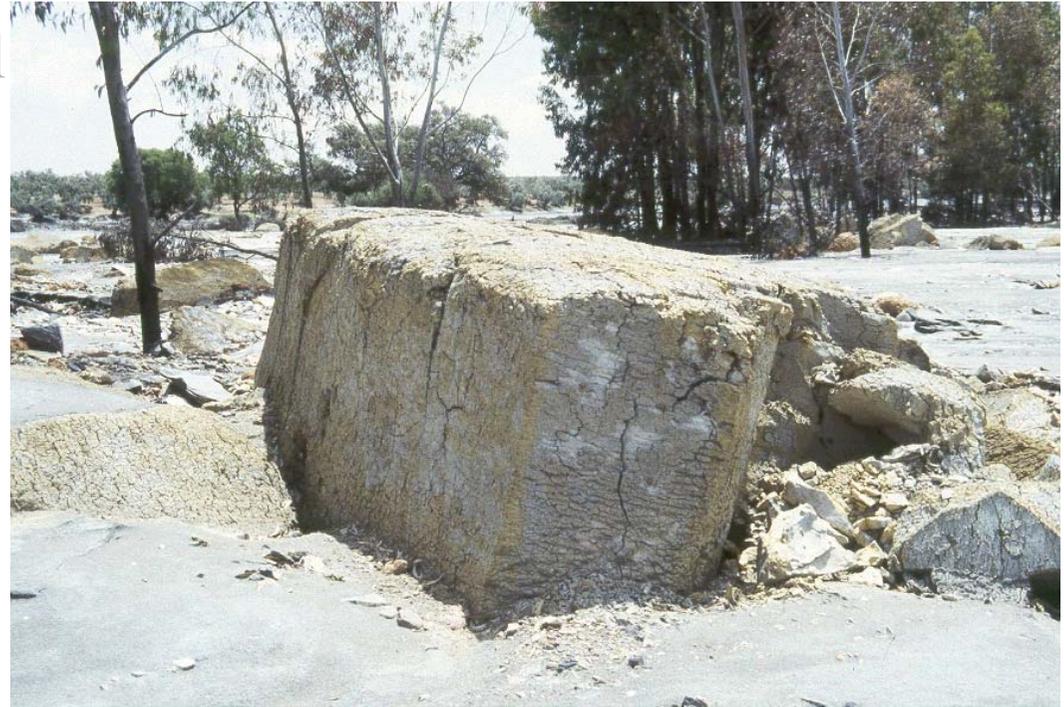
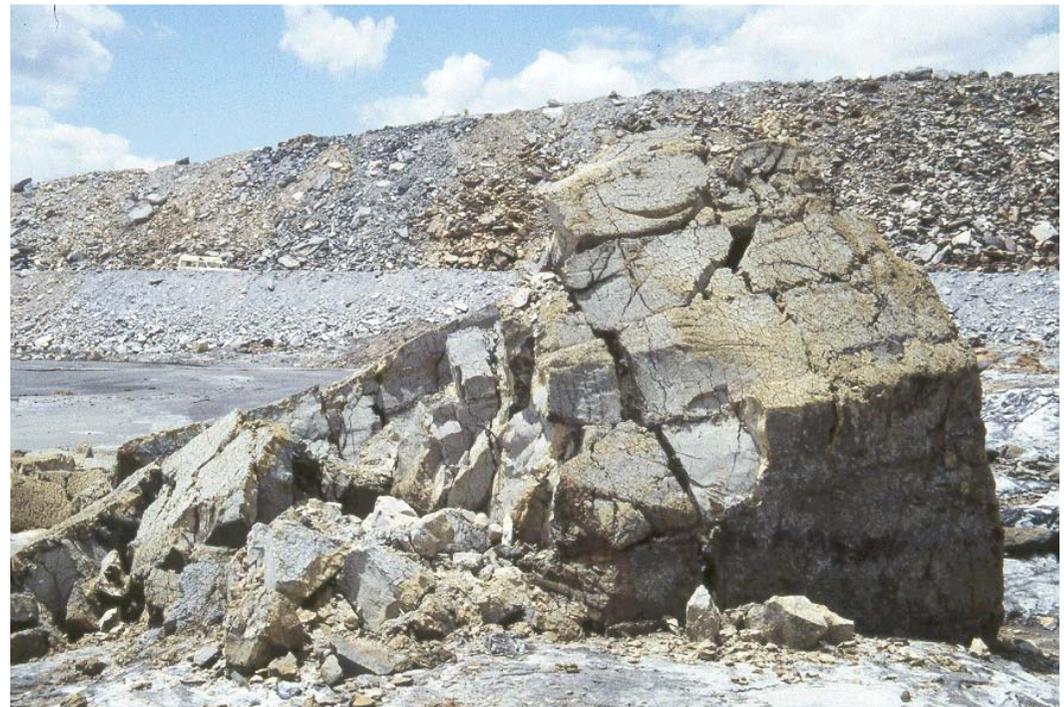
Clay blocks « floating »
on the tailings flow

- Parallelepipedic shape
- Sharp edges
- Joints covered by oxidation coatings

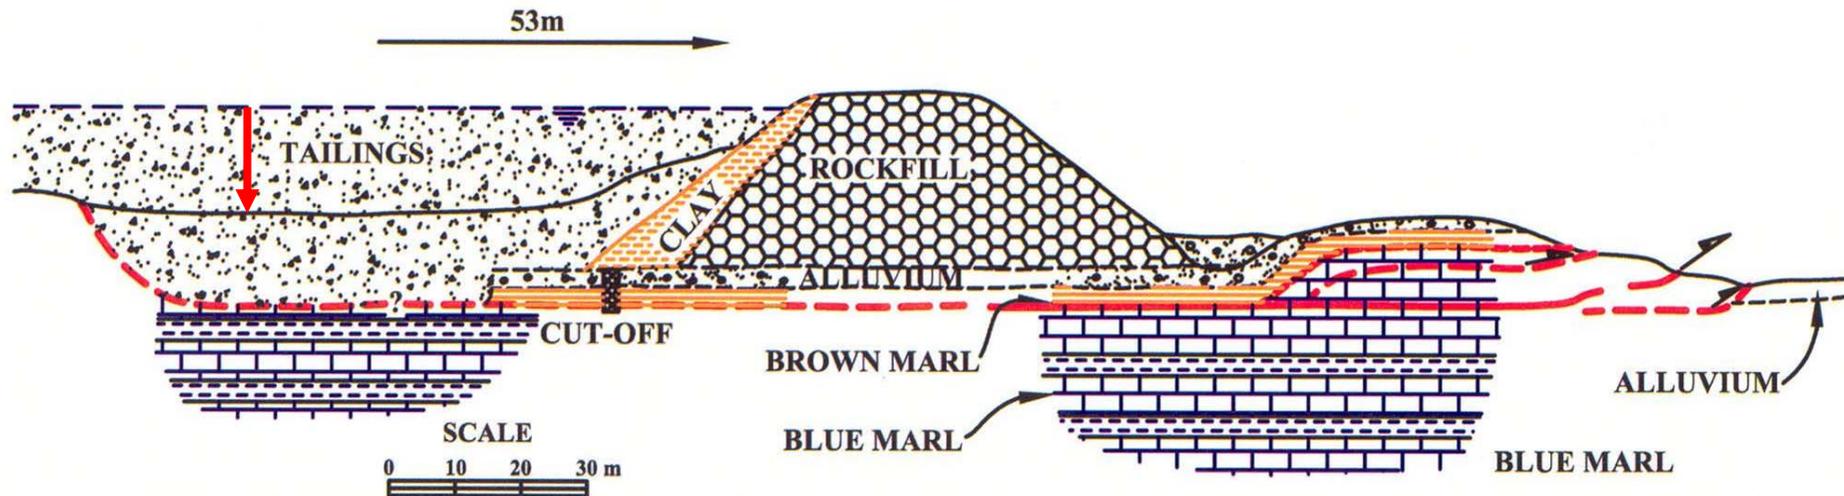
- Basal failure surface located within the blue clay at 12-14m under the surface)
- Solid rigid motion of dyke, upper alluvium and an upper layer of clay
- Downstream accumulation of folded strata
- Upper trough partially filled by tailings

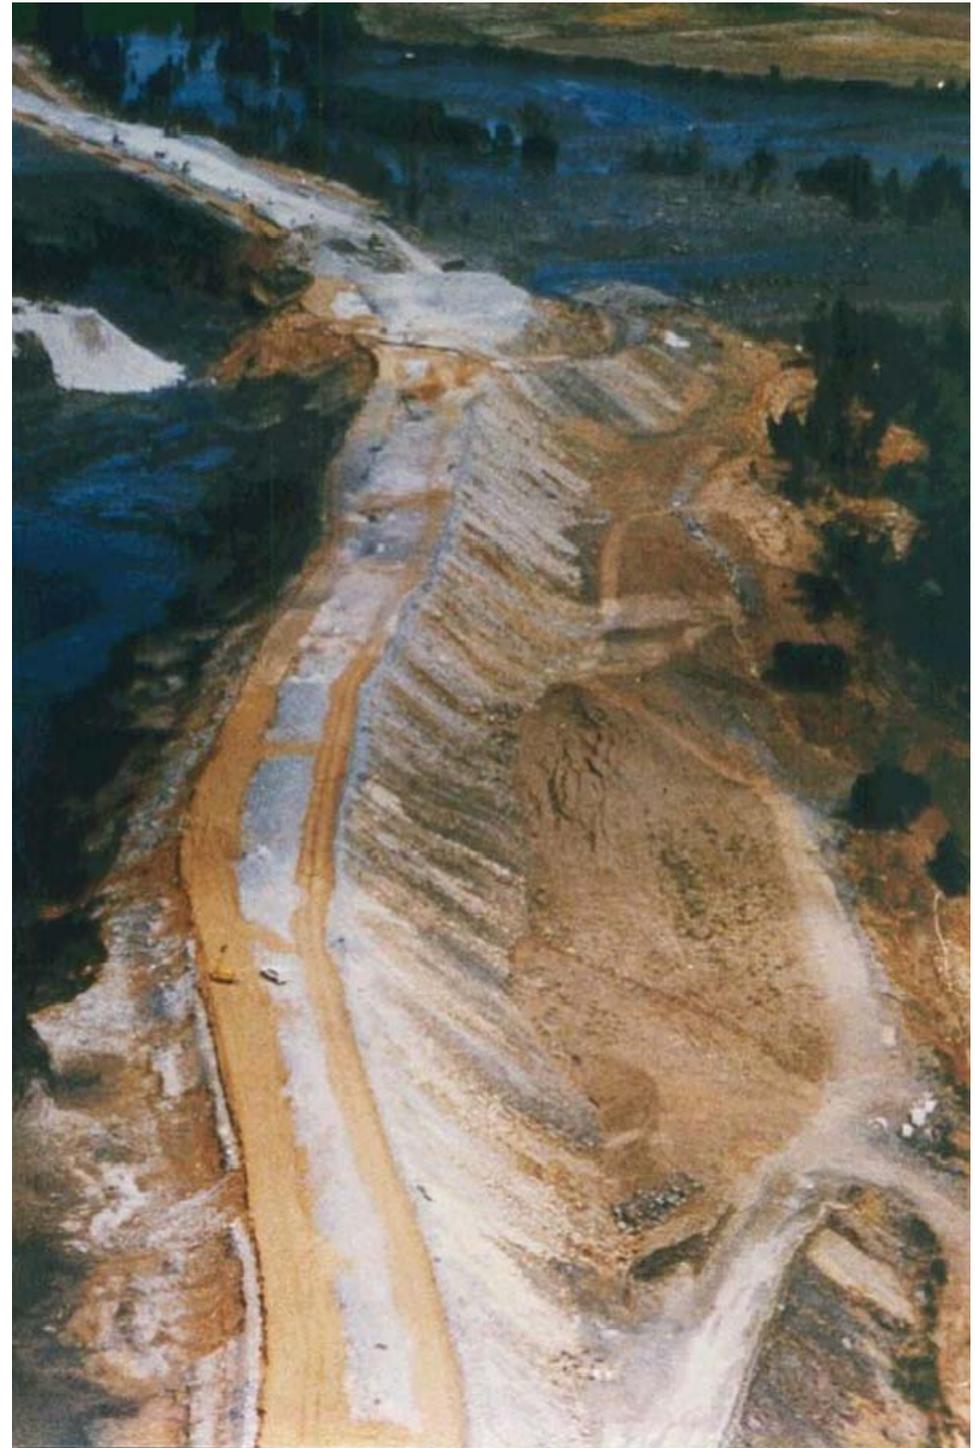
The downstream edge of slide

- Apparent heave of the ground (7-8 m of vertical displacement)
- Surface bent and cracked. Cracks parallel to dyke
- Folded layers identified
- The motion had a slight rotation towards the South

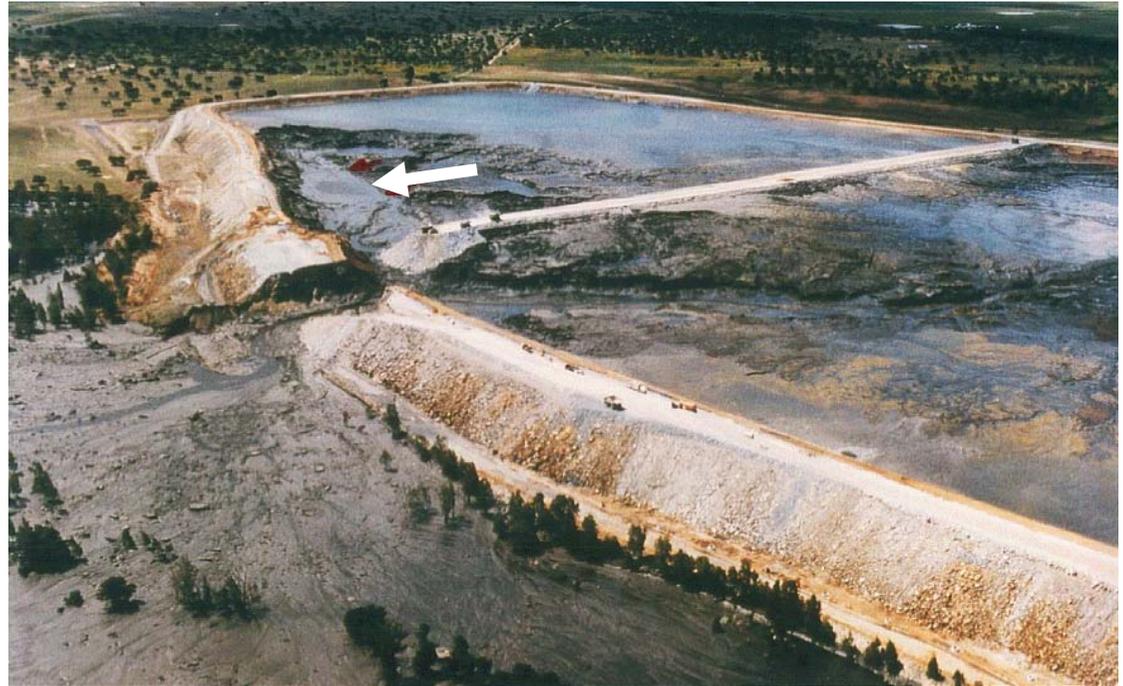
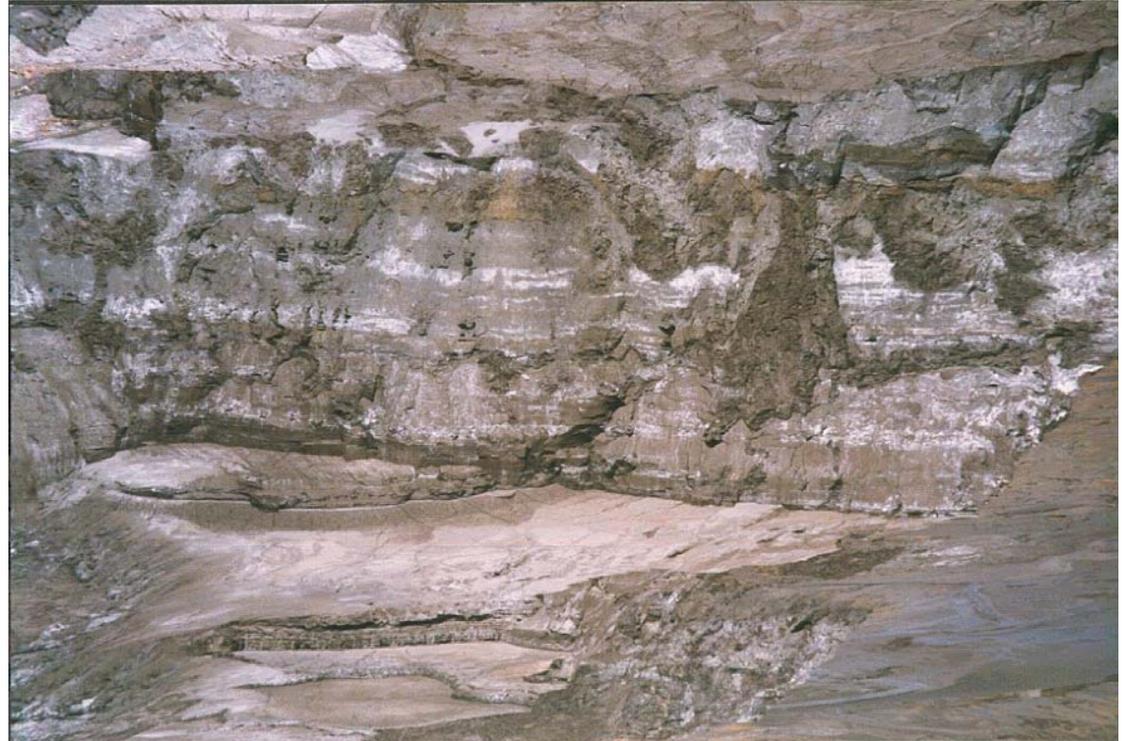
Head of the slide

- Vertical upstream cliff located in the original position of the foot of the dyke upstream slope
- The slide motion led to the opening of a large upstream depression basin. The red clay mantle became unstable

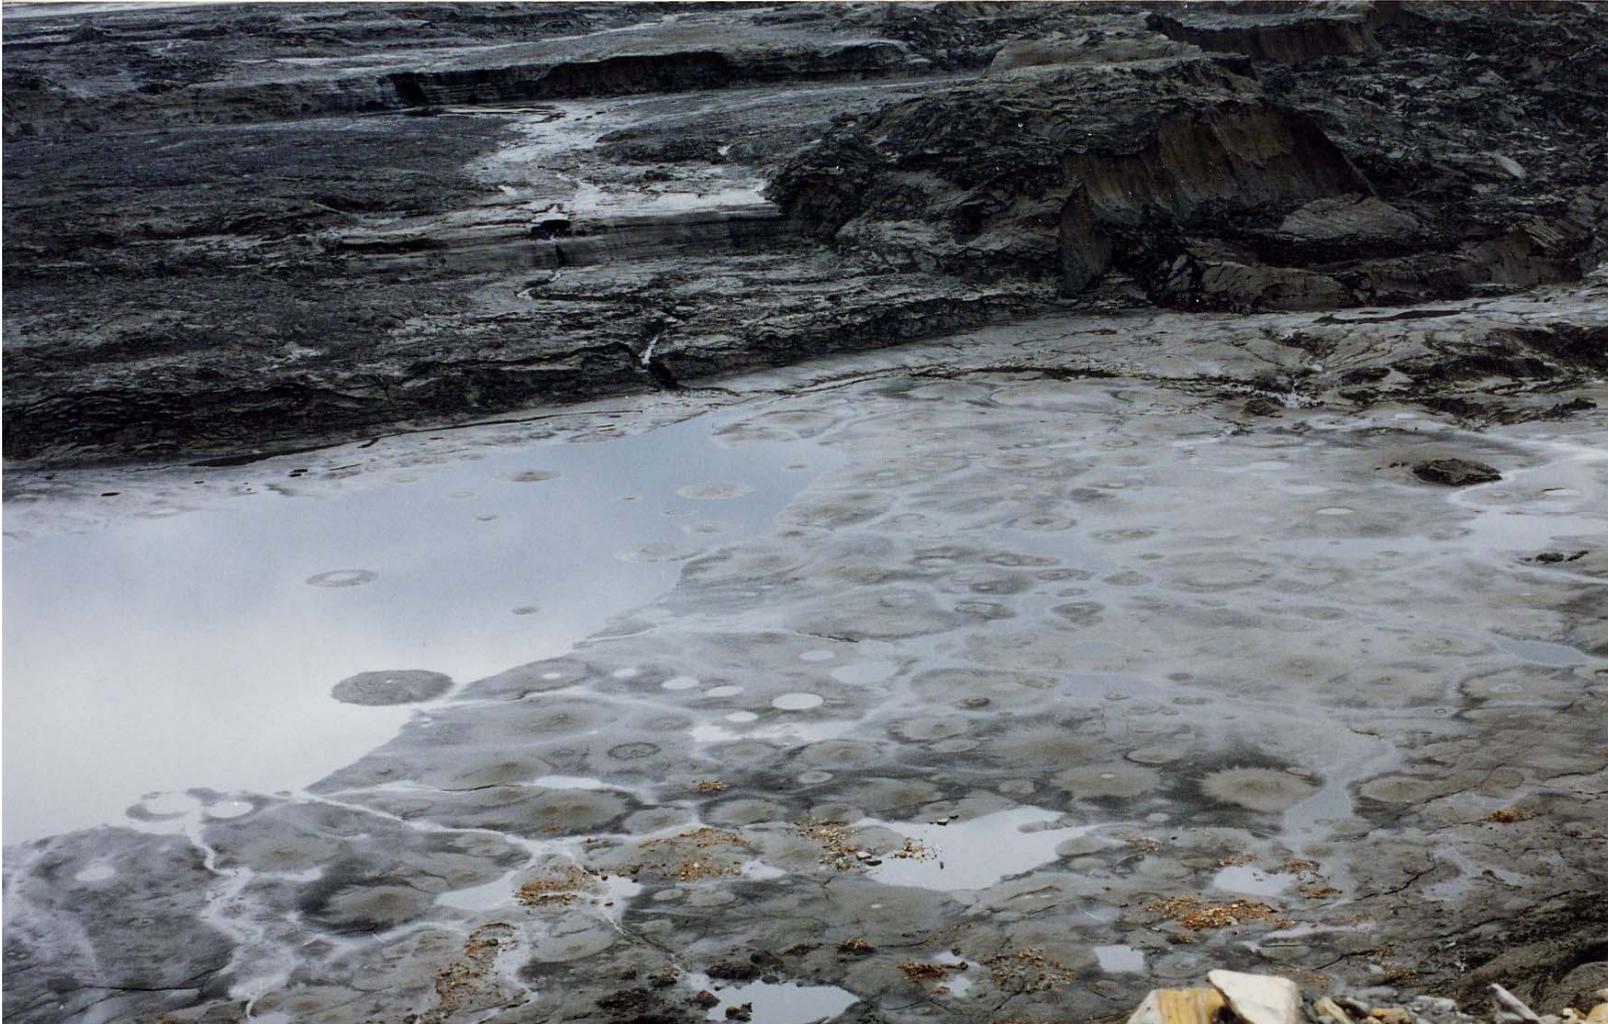
- Mud volcanoes were observed disseminated on the upstream depression surface

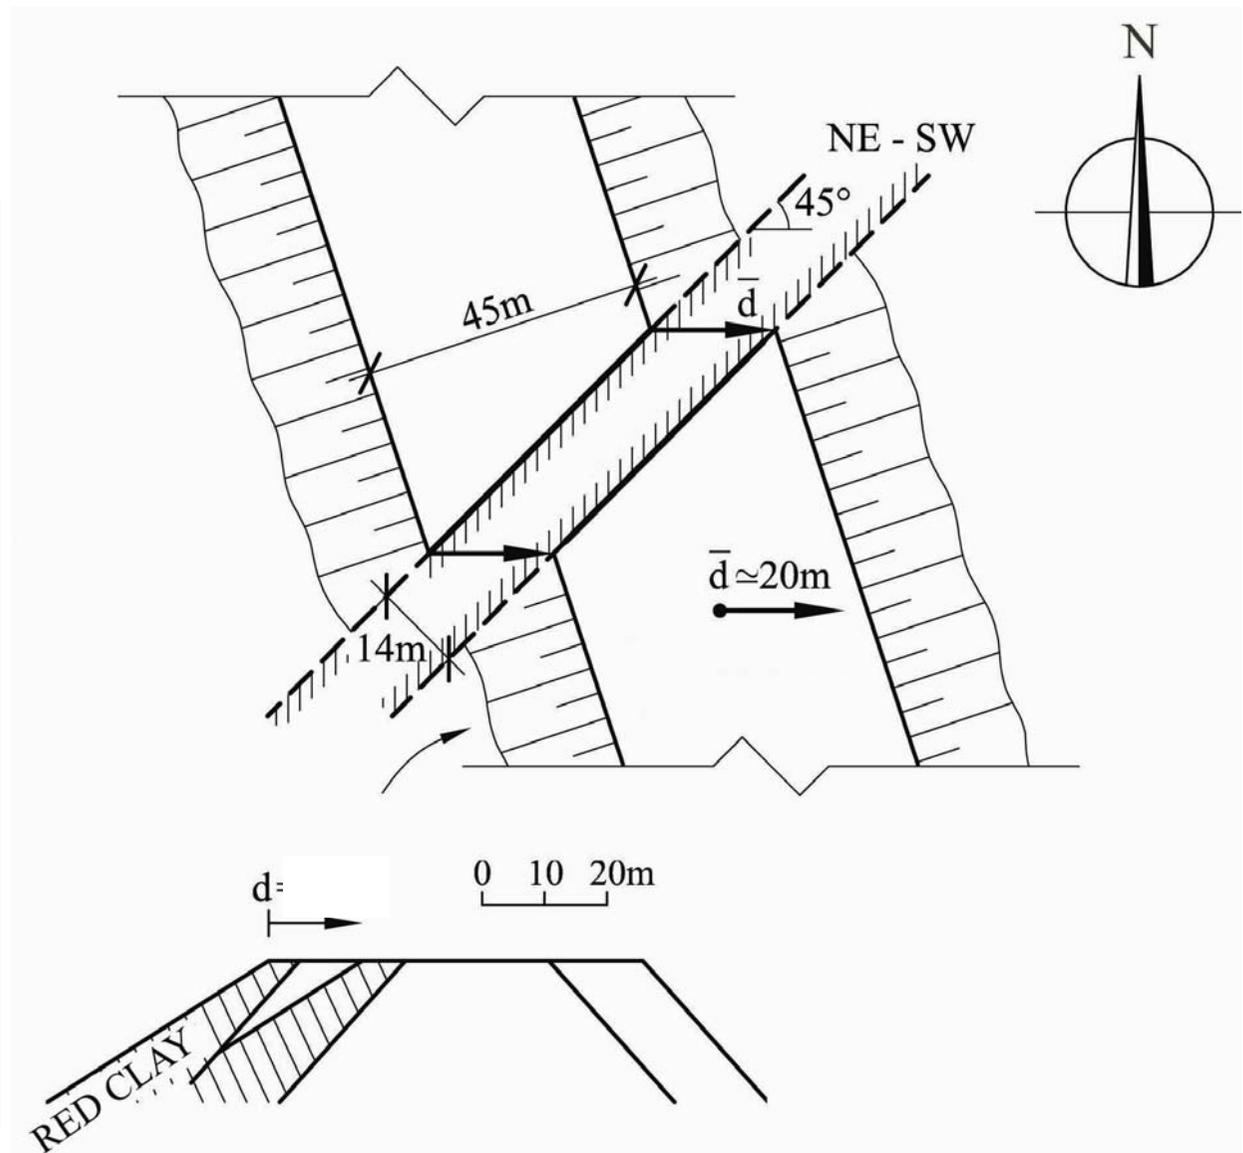
Rupture breach in the dyke

- It was interpreted that the breach orientation was controlled by a joint of the NE-SW family
- The slide motion implies an opening of the breach
- It is estimated that the initial channel had an opening of around 14 m since the dyke was displaced $d=20$ m in the East direction

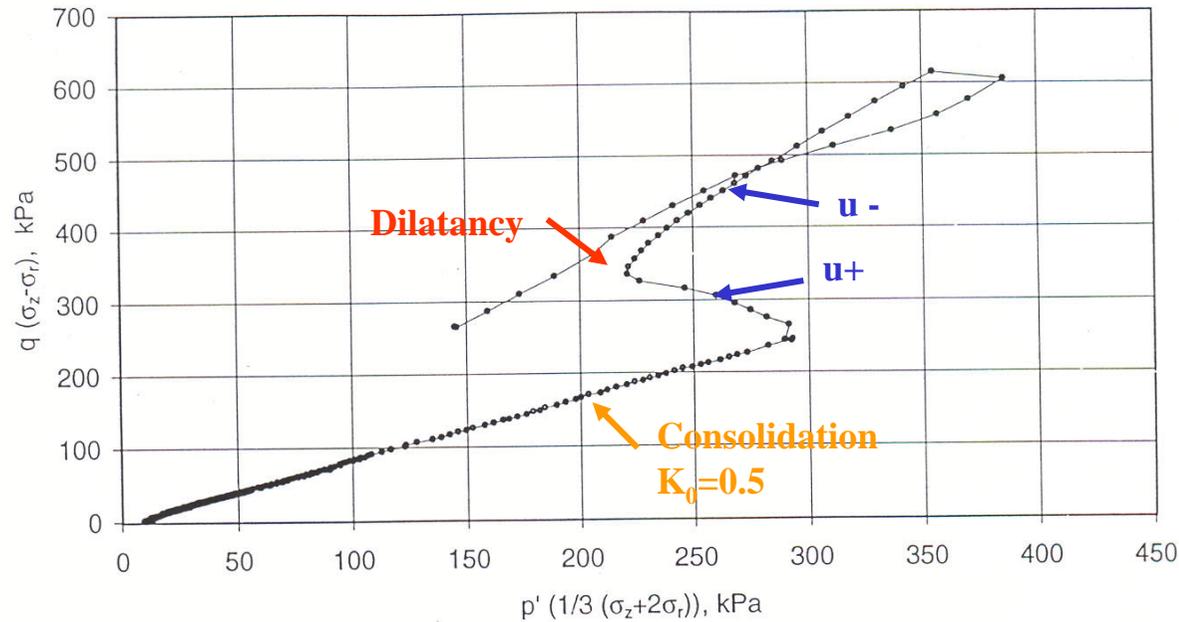
Undrained triaxial tests on pyrite specimens

Tests CAU on specimens taken in boring S-5.2

- Static liquefaction was not observed
- Homogeneous failure conditions in depth

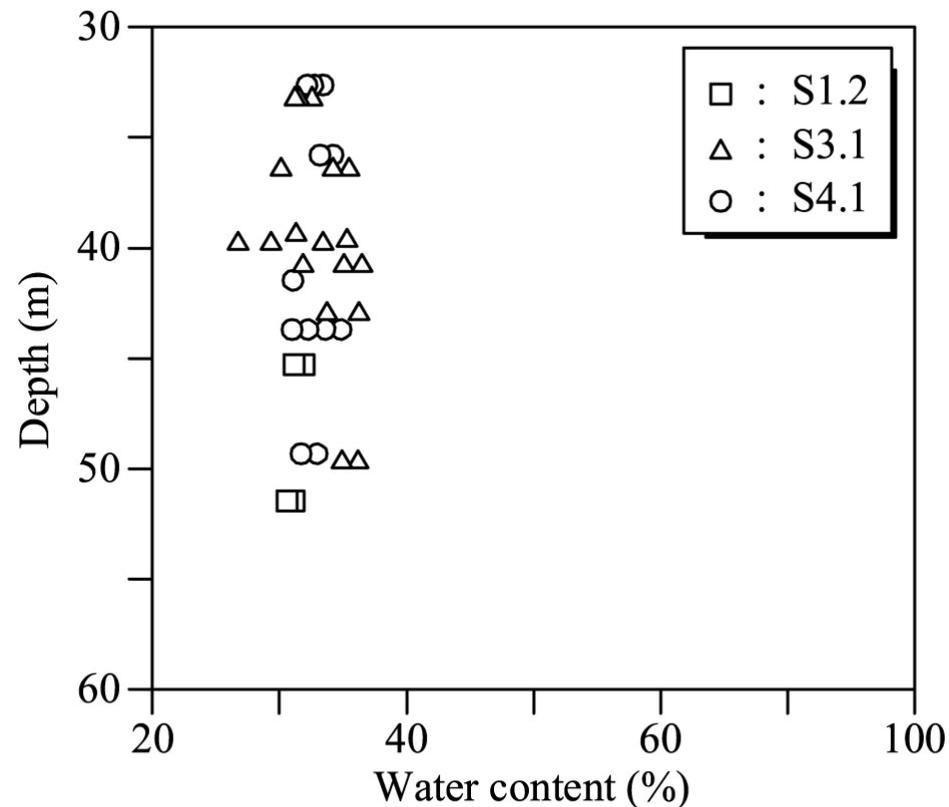
Basic identification

- Slight variation of density, water content and void ratio with depth ($w = 30-35\%$; $\gamma_{\text{nat}} = 1.90-1.98 \text{ g/cc}$; $e = 0.8 - 1.0$)
- Percentage of : Fines: $>98\%$; Clay: 47-58%
- Plasticity: $w_L = 63 - 67\%$; $IP = 32 - 35\%$
- Classification: MH or CH

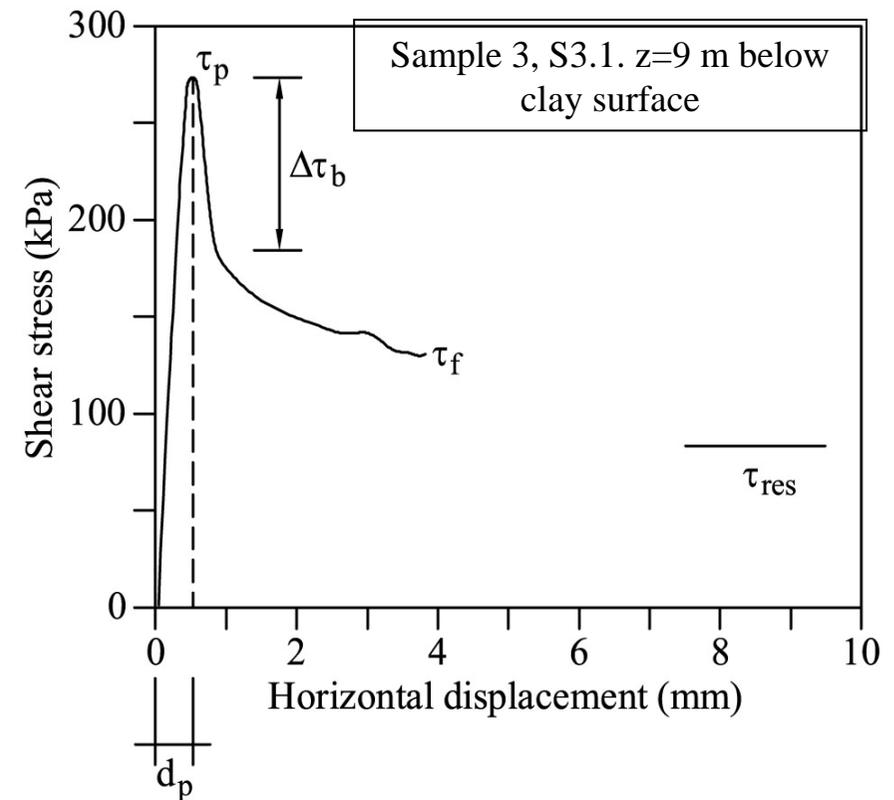
Clay matrix. Drained direct shear

➤ Quasi-brittle behaviour

- Displacement (d_p) at the peak strength, $d_p < 1\text{mm}$

- Sudden strength reduction, $\Delta\tau_b$

- Brittleness indexes:

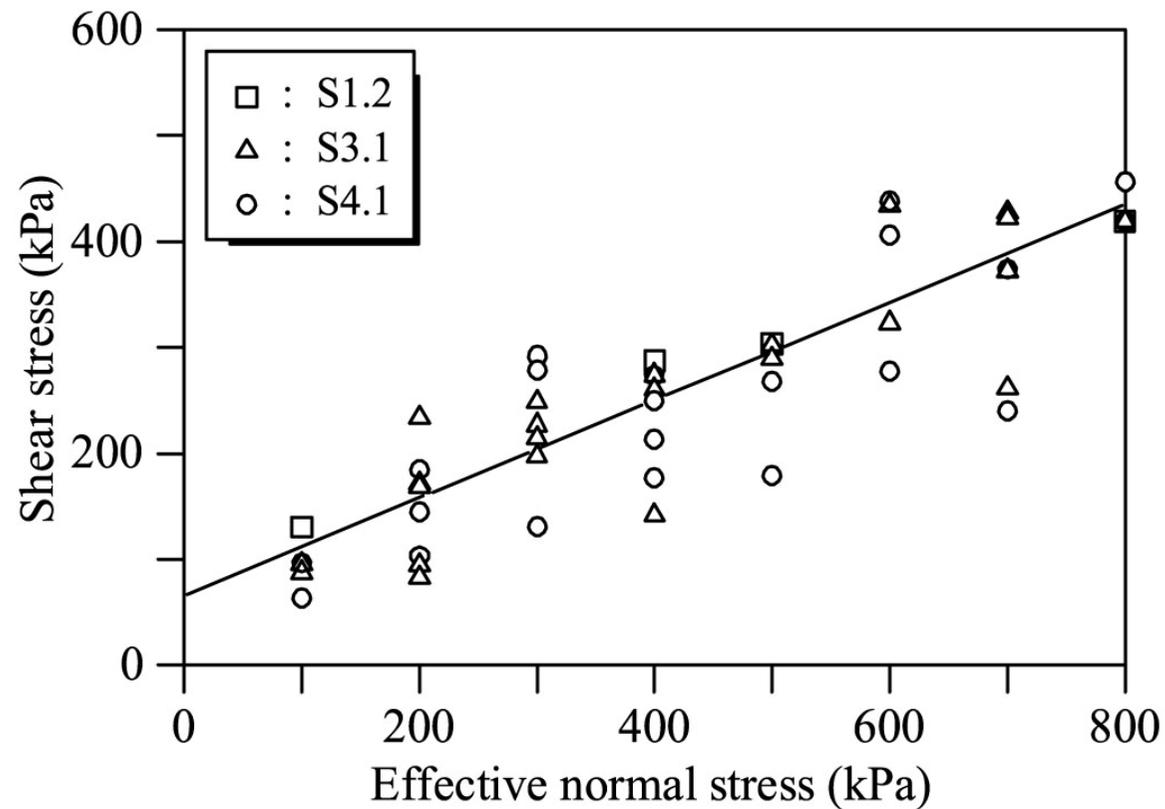
- Some dispersion observed in tests
- Average drained strength parameters:
 - Peak: $c' = 65$ kPa; $\phi' = 24.1^\circ$. End of test: $c' = 0$; $\phi' = 15^\circ - 23^\circ$

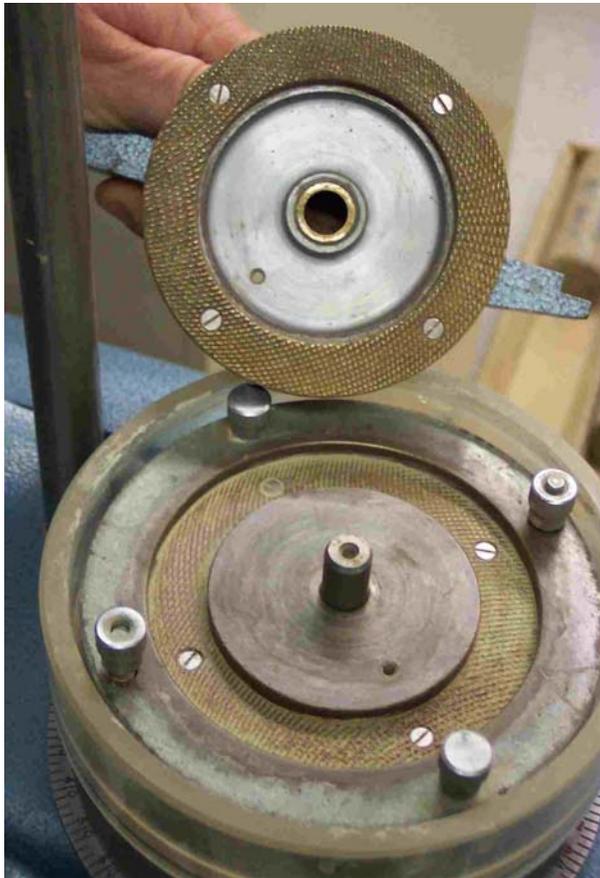
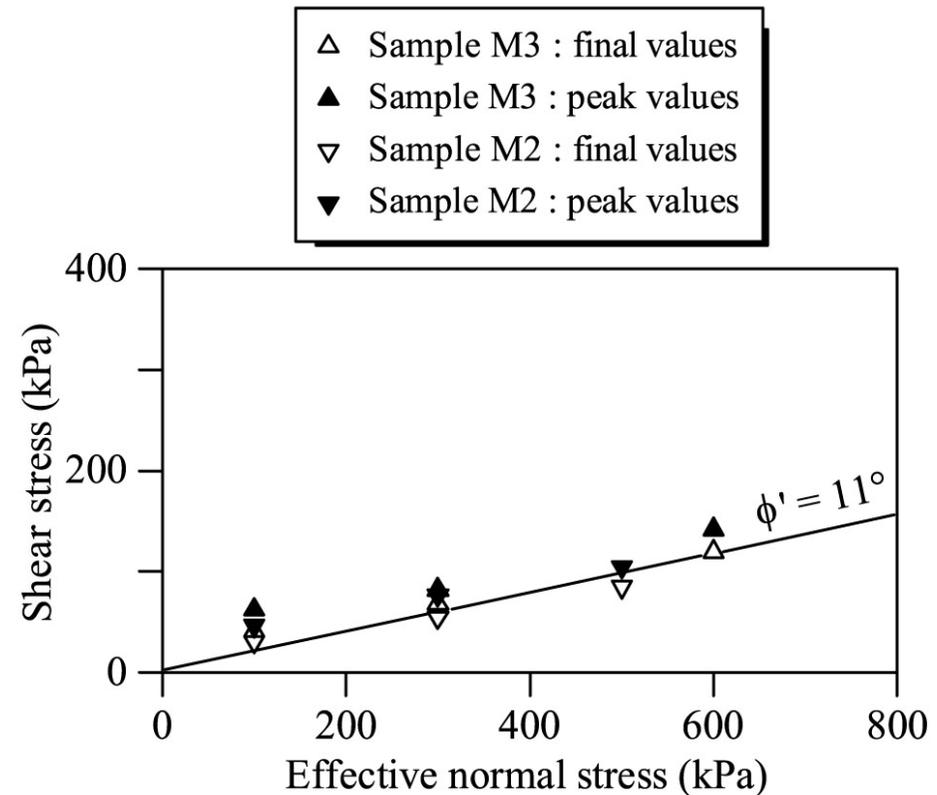
Ring shear tests

- Remoulded soil (samples recovered in borings; block samples)
- $\phi'_{res} = 13^\circ$ (average)
- Uniformity of ϕ'_{res} in the upper 20 m of clay

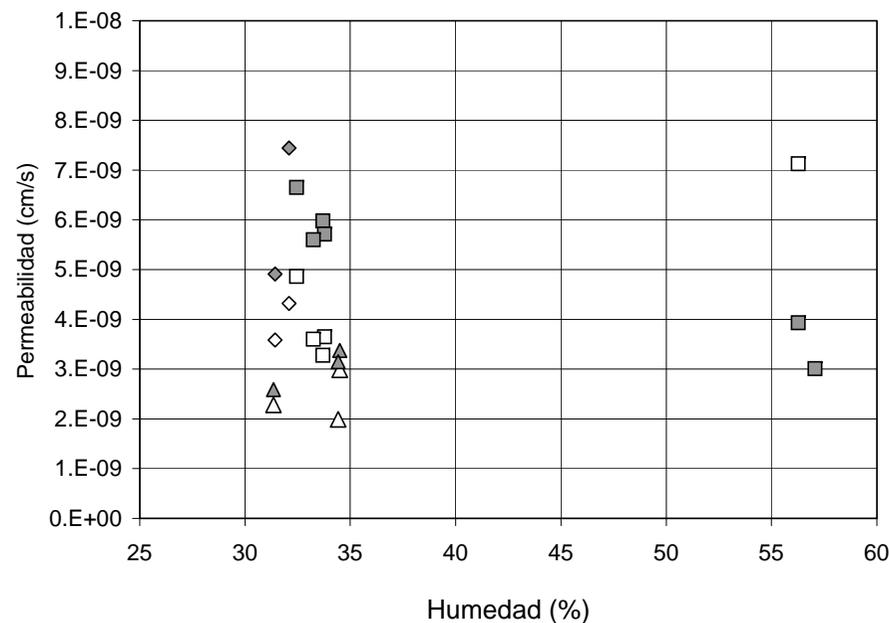
Oedometer tests. Coefficient of consolidation. Permeability

• Tests were interpreted through a model: Primary consolidation + secondary + initial deformation (δ_0 , c_v , E_m , C_α) (Back analysis)

• c_v : 0.5 to 1.5×10^{-3} cm²/s

• K : 2 to 7×10^{-9} cm/s

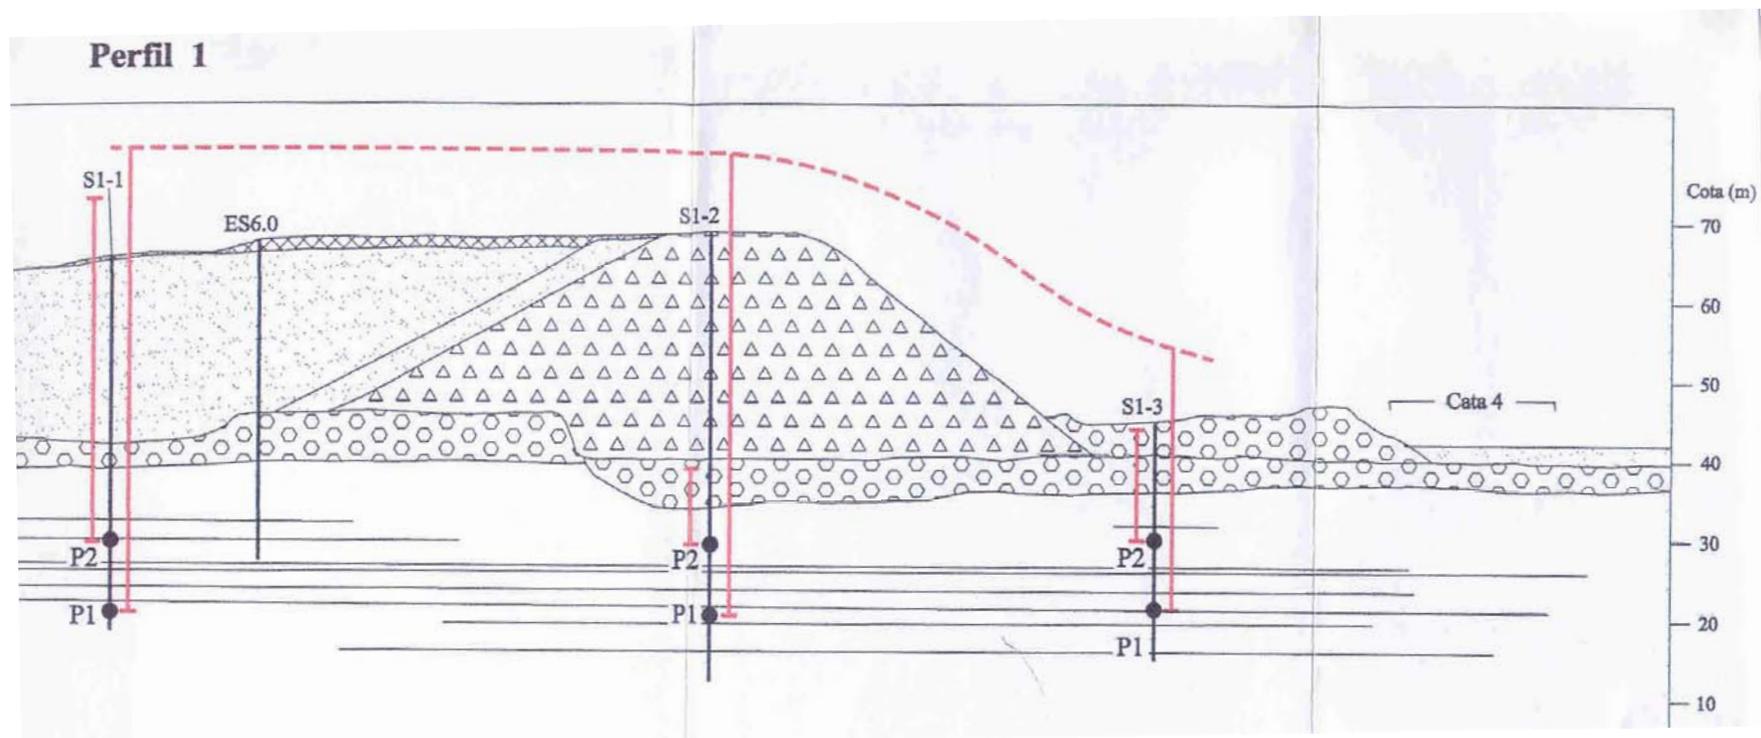
Measured pwp profile after failure (in October 1999, after stabilisation)

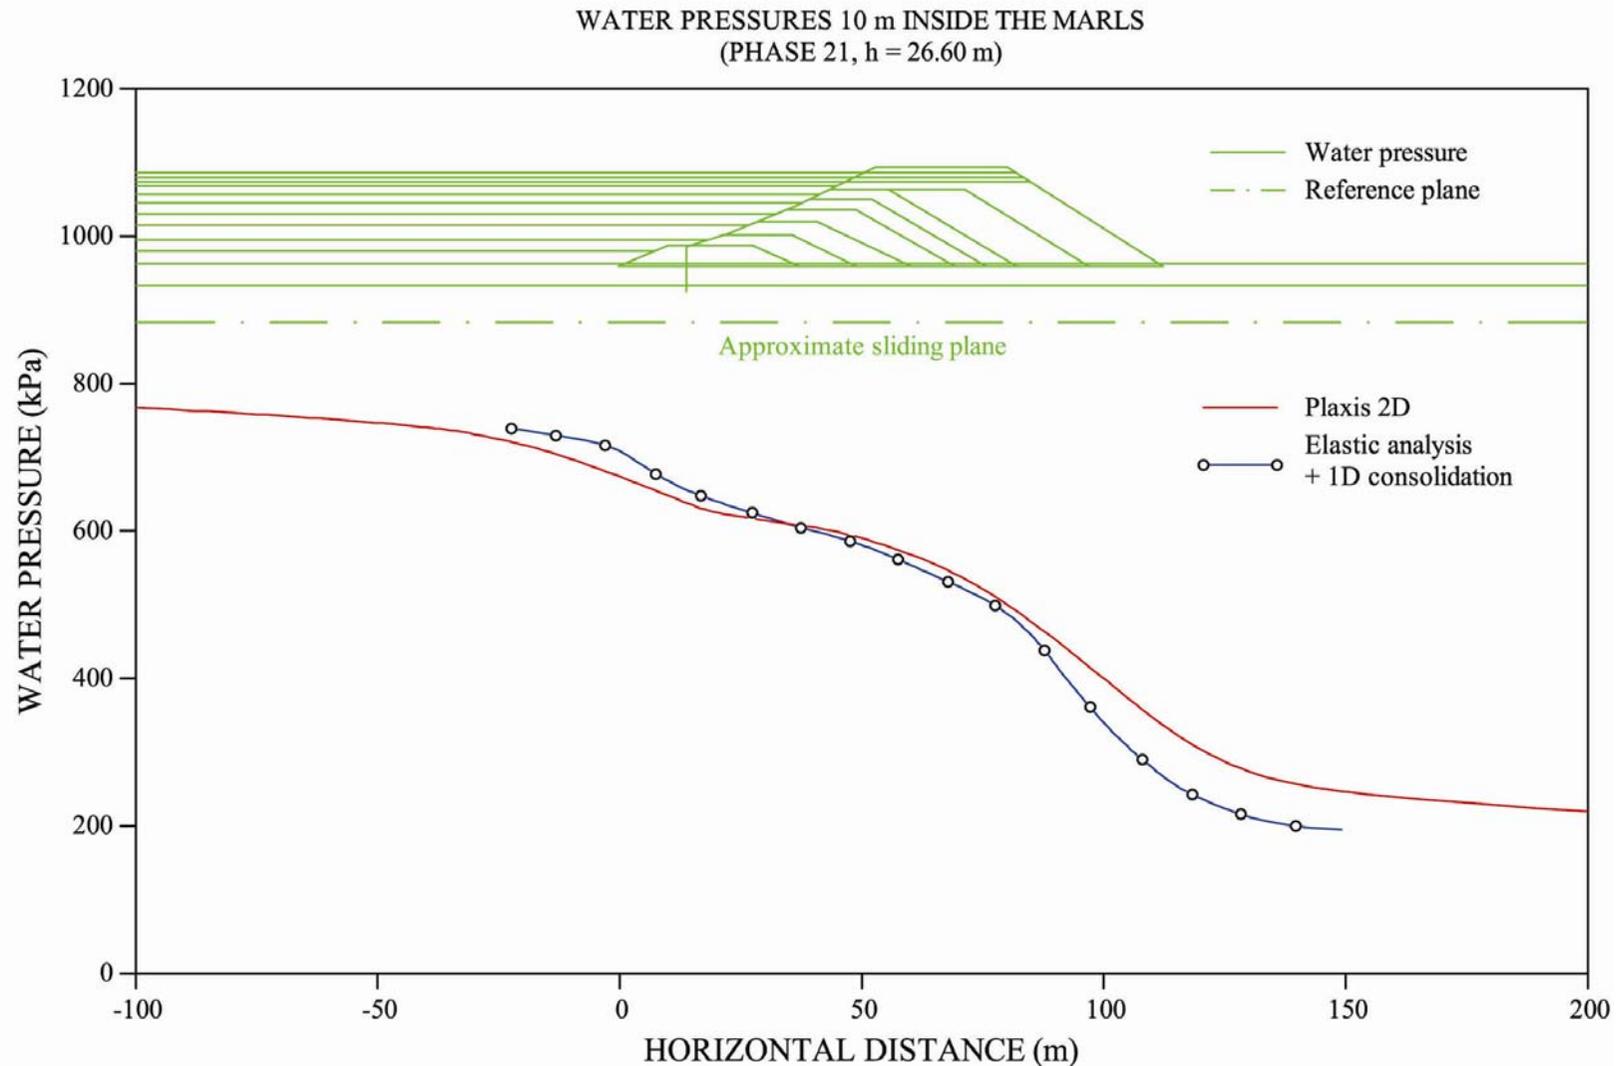
Calculated water pressures in section 3 (pyrites basin) on the sliding plane at the time of the failure

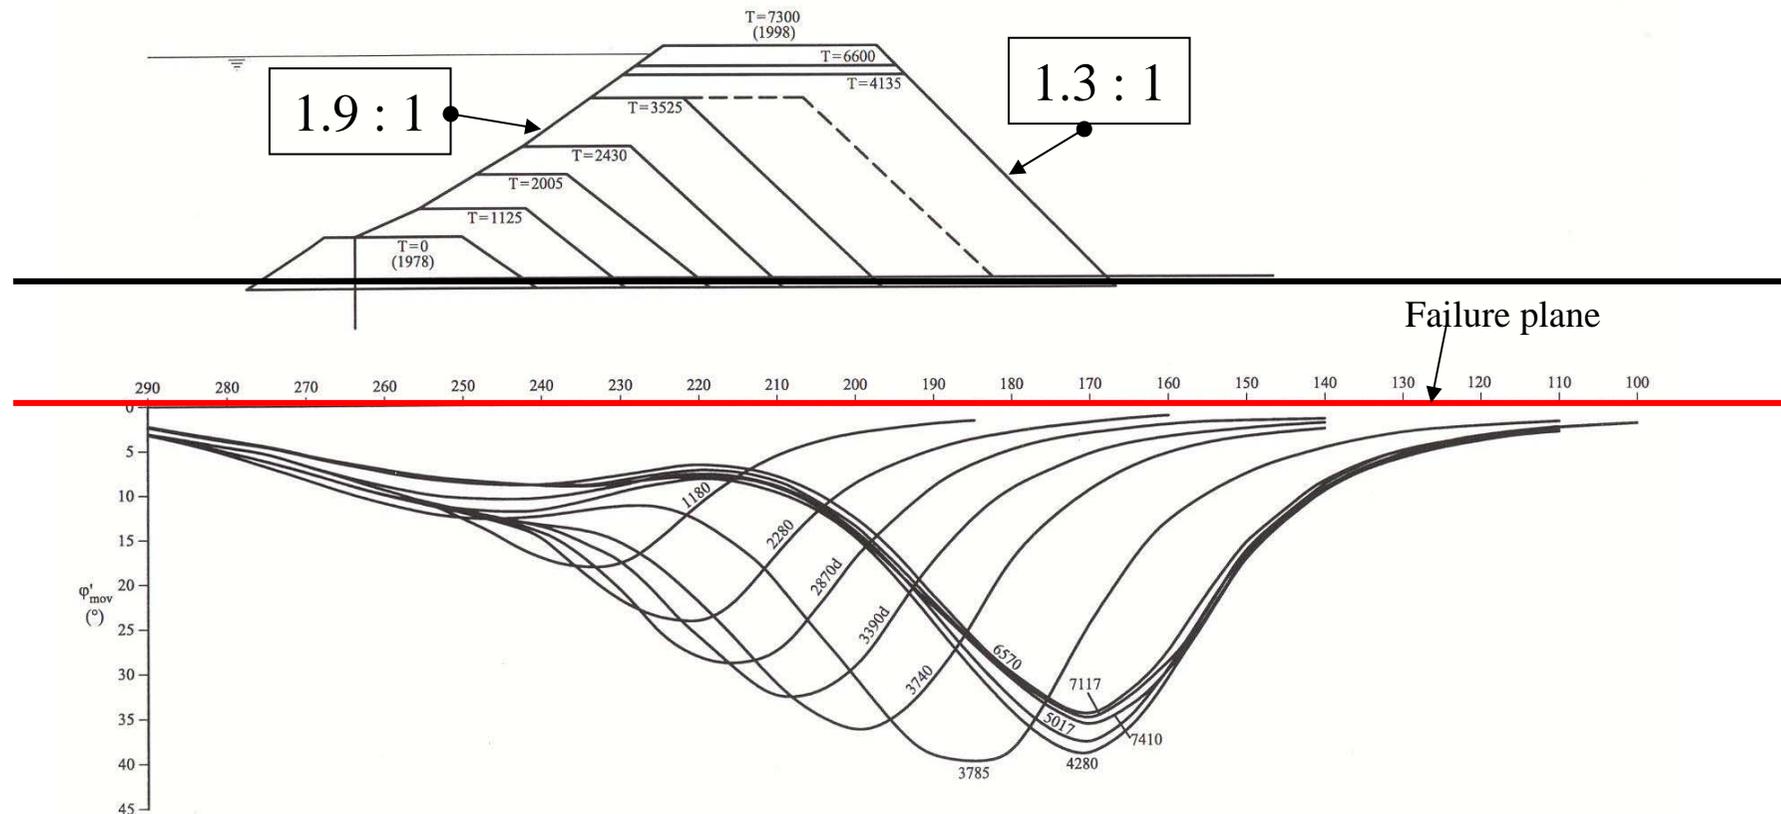
Stresses under the dyke (pyrites basin)

- Progressive failure phenomena could start when the dyke reached a height of 18 m

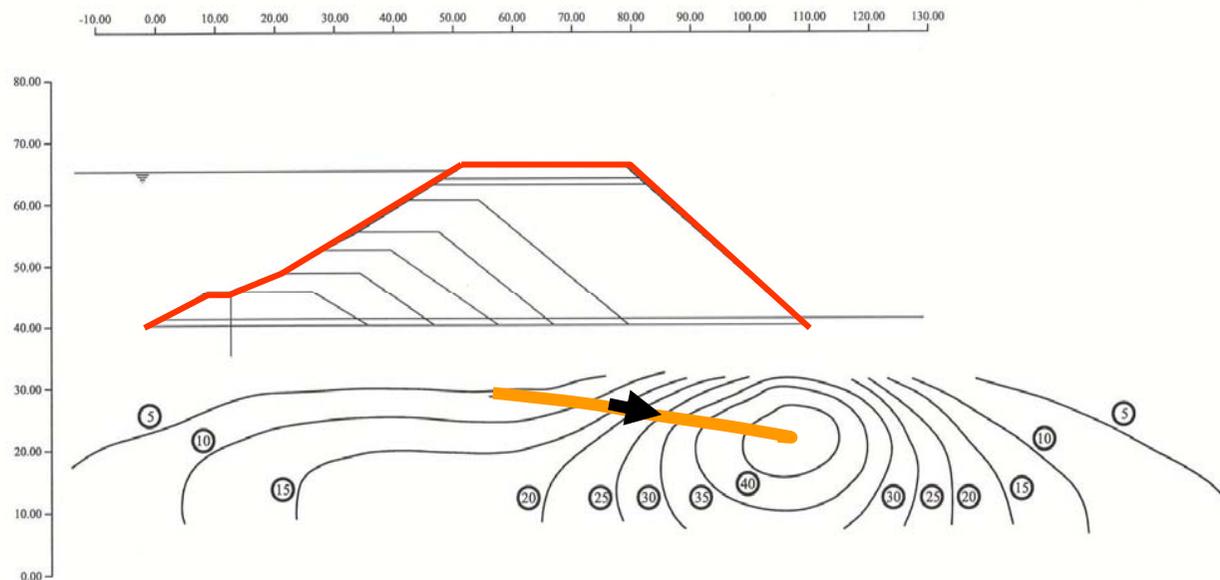
Evolution of mobilised stress ratio in the foundation

- The value of τ/σ'_n reaches a maximum value at a certain depth under the downstream foot of the dyke
- This depth changes slowly, as the size of the dyke increases
- The curve joining the position of maxima marks probably the position of the sliding surface and the evolution of progressive failure

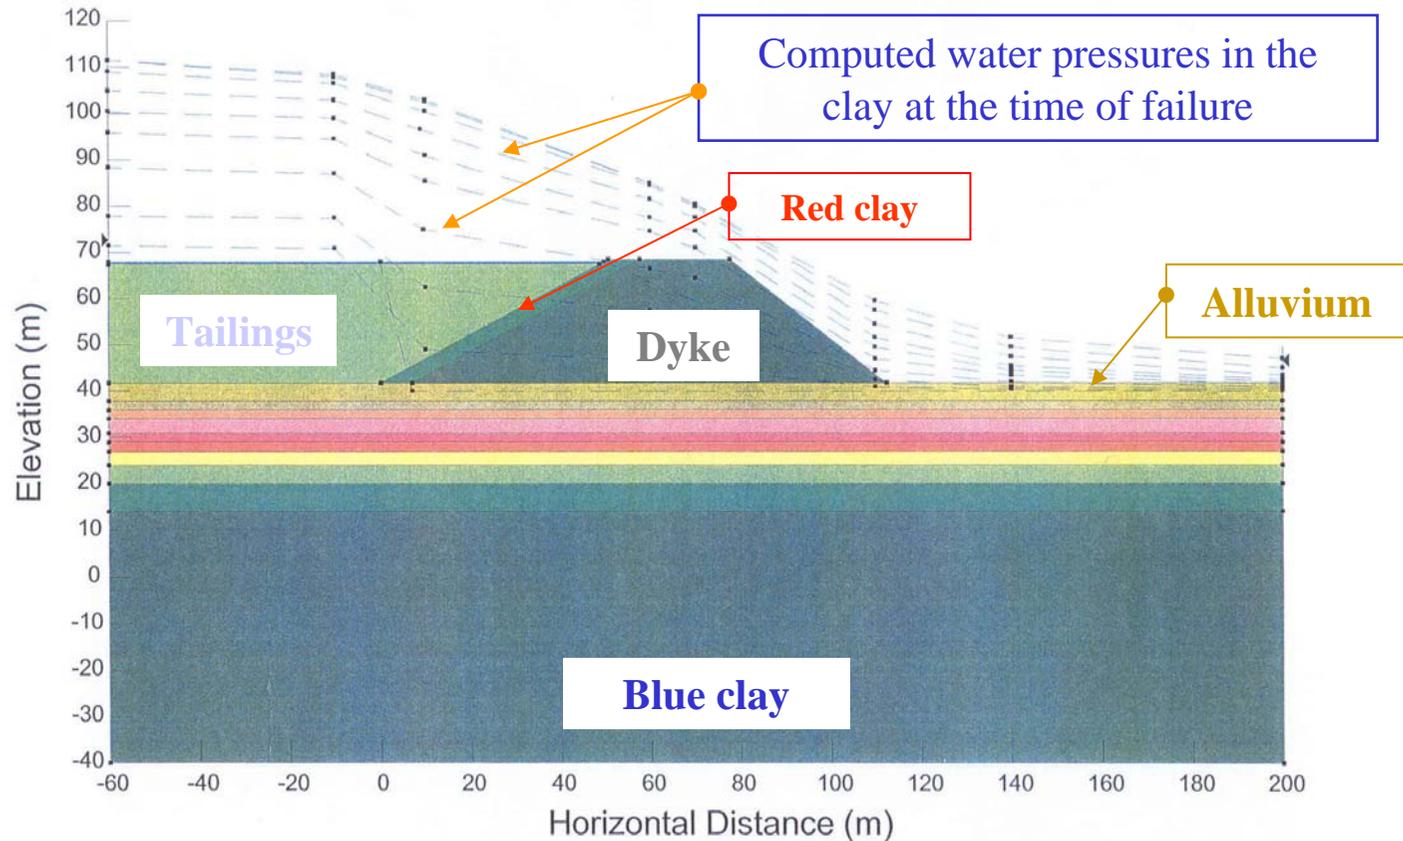
Reference cross section for calculations

Material	Density (kN/m ³)	Friction (°)	Cohesion (kPa)
Tailings	31	37	0
Red clay	21	27	0
Dyke	20	40	0
Alluvium	20	35	0
Blue clay	19.5	Variable	Variable

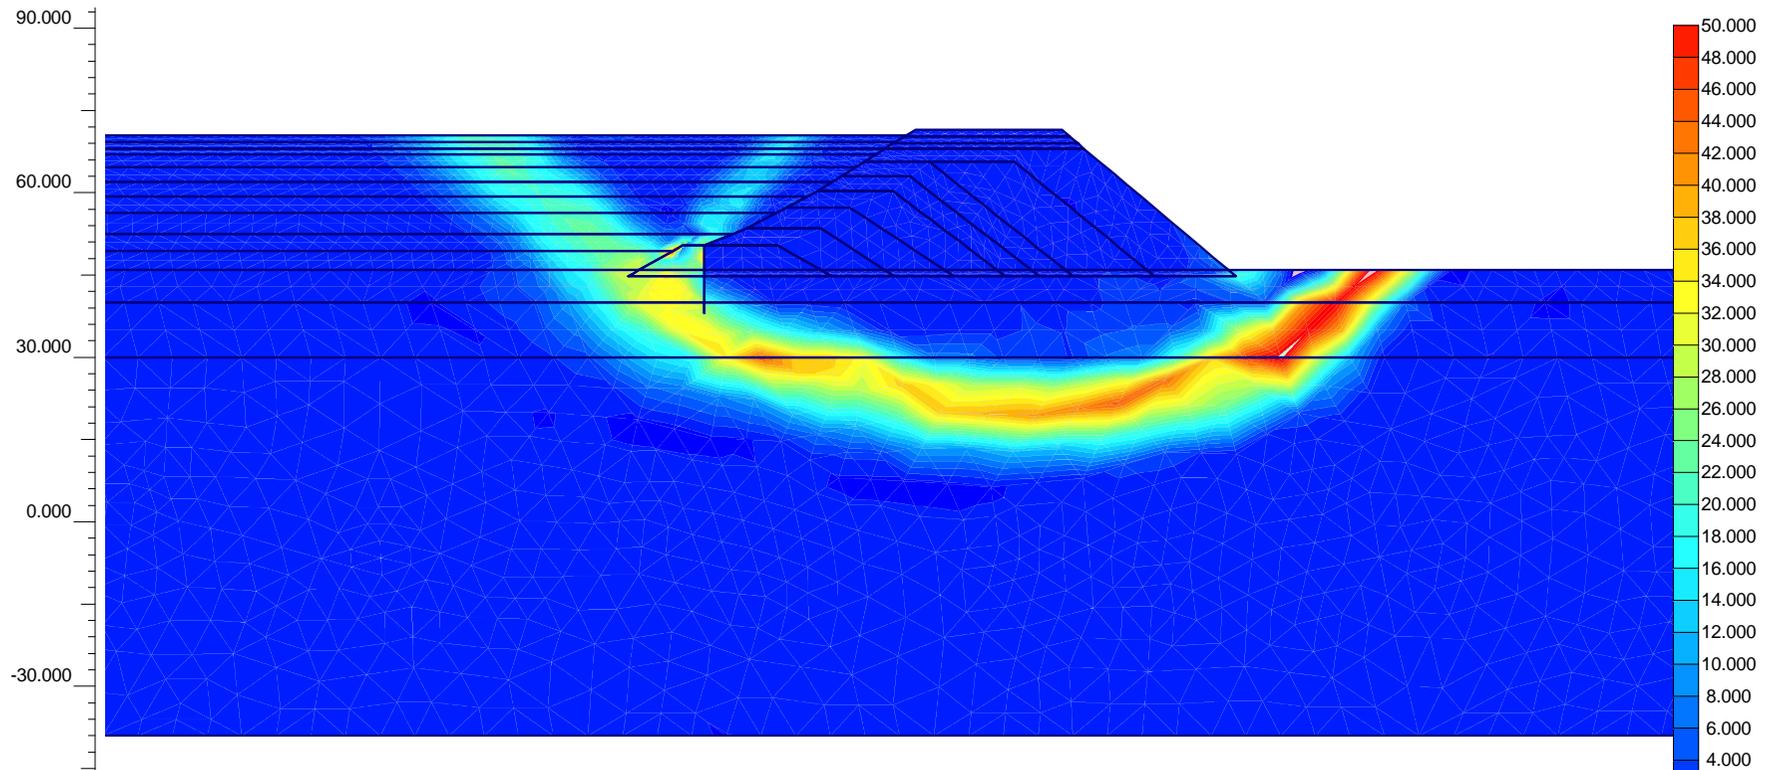
- If $c' = 65$ kPa et $\phi' = 24^\circ$ (peak) there are no plastic points: progressive failure does not develop
- Deep failure surface mechanism (similar to the worst mechanism found through limit equilibrium)

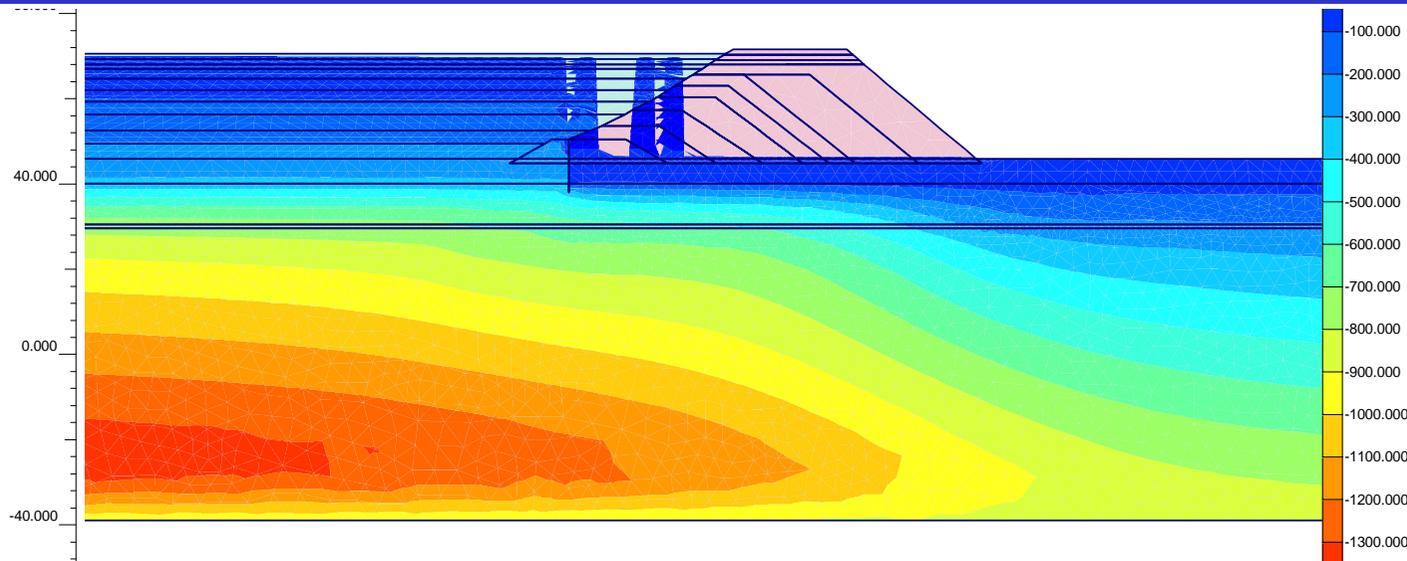
- If the chosen strength parameters reproduce the final failure, it is found that the dyke was unstable in Phase 11 (1988)
- Chosen parameters:
 - Clay in failure band and upper zone (1978-1988): $c' = 15\text{kPa}$, $\phi' = 21.5^\circ$
 - Clay in failure band and upper zone (1988-1998): $c' = 1\text{kPa}$, $\phi' = 21.5^\circ$
 - Clay below the failure band : $c' = 15\text{kPa}$, $\phi' = 21.5^\circ$

Pore water pressures contours calculated for the final phase
