Geotecnia e Ingeniería Sísmica aplicadas a la Minería

LA ROTURA DE LA PRESA DE AZNALCÓLLAR

Eduardo Alonso

Aznalcóllar dam failure

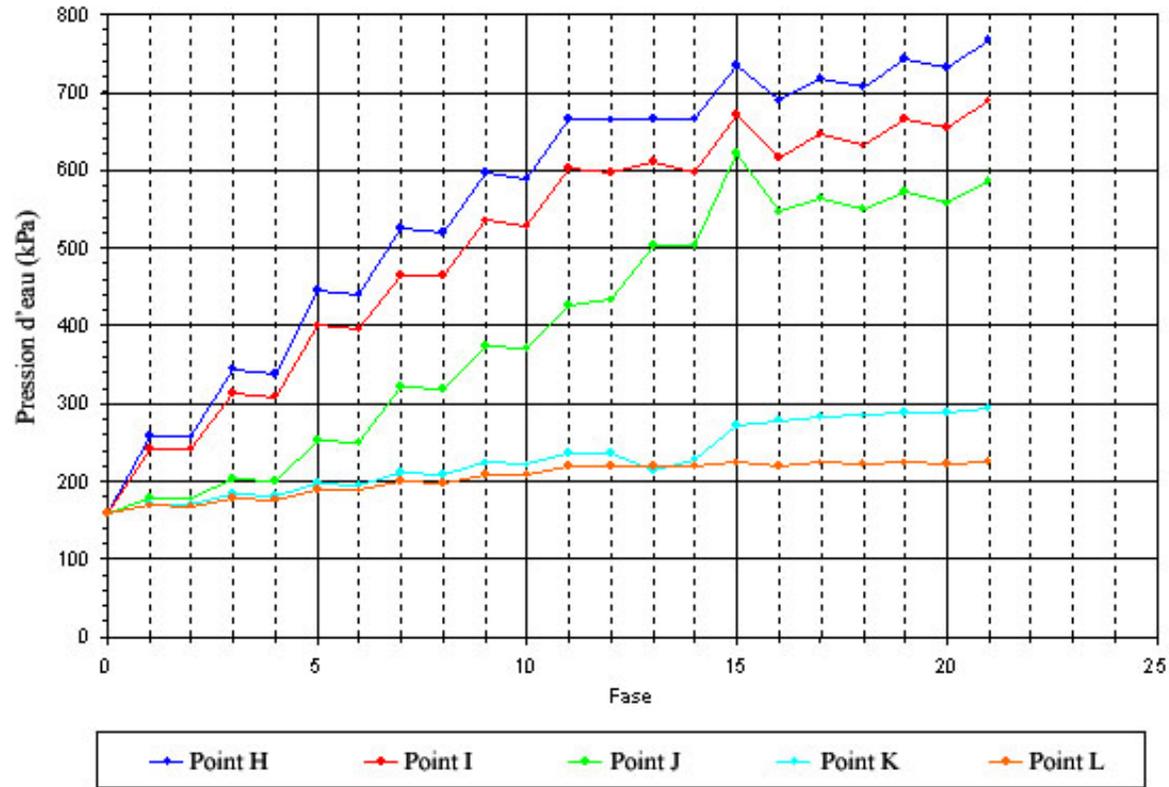
● Very limited dissipation of pwp

Position of points in failure surface

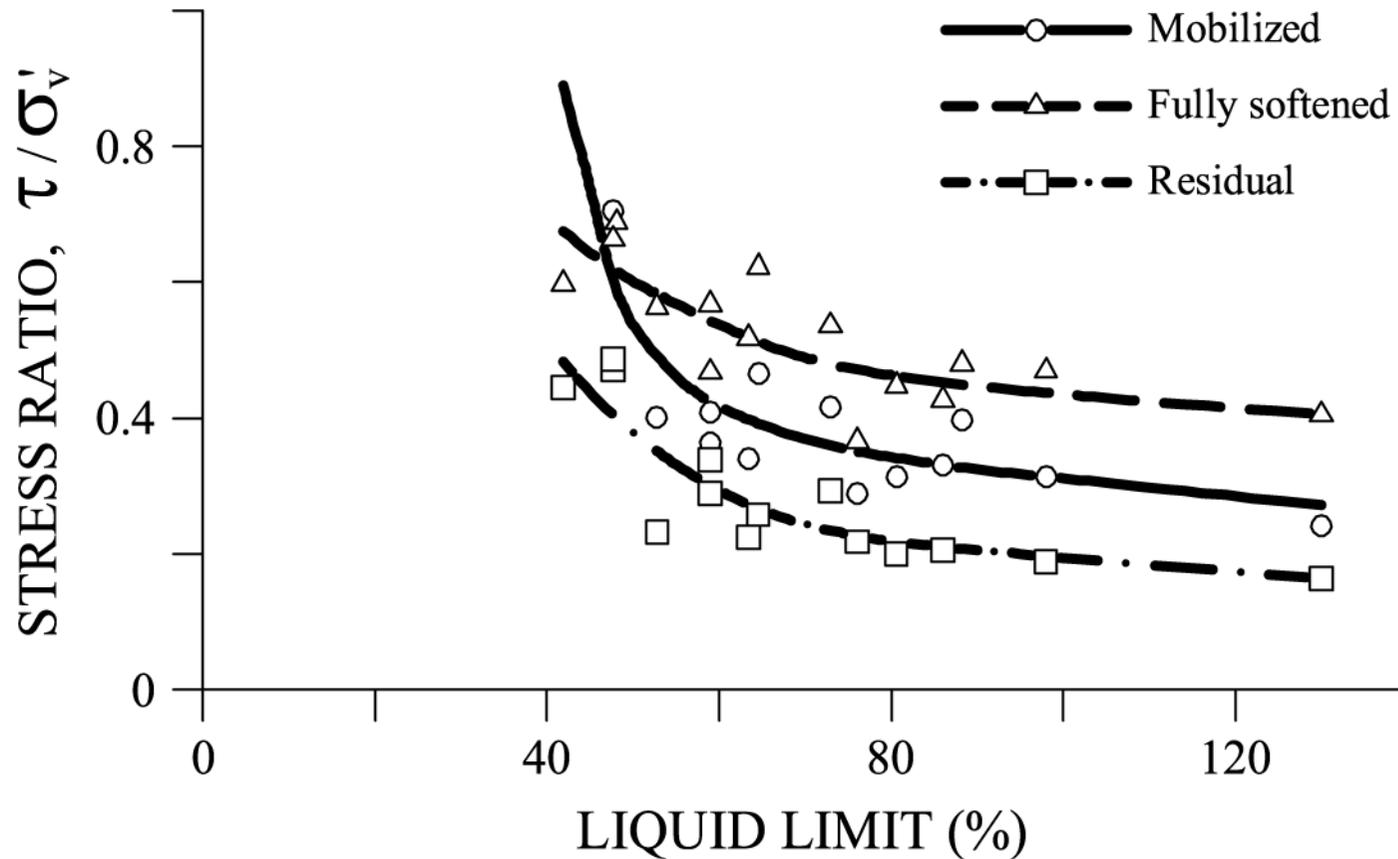
Back analyses of mobilized strength in first time failures in hard and fissured clays (*Stark and Eid, 1994*)

• **Conclusion:** Mobilized strength is intermediate between FSS and the residual strength

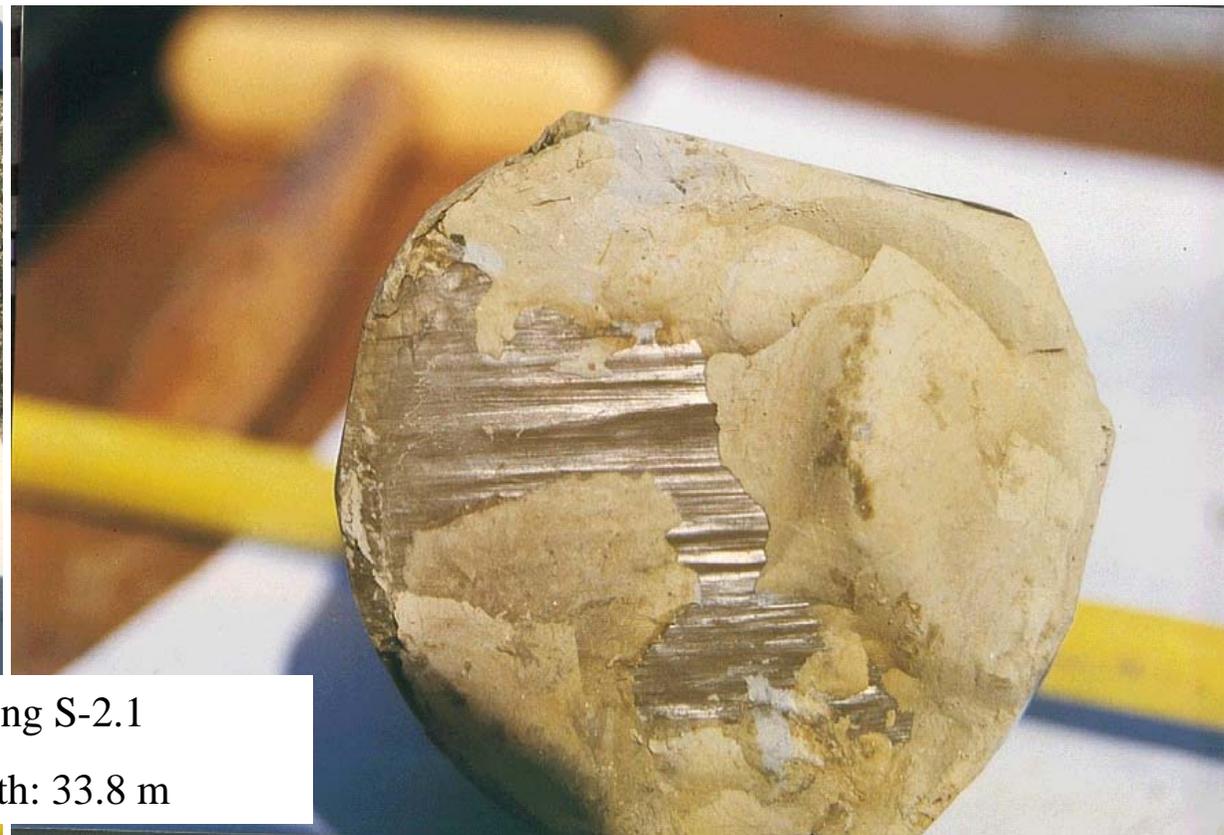
Boring S-2.1
Depth: 33.8 m

Slickensided plane found in boring S-2.1 at the position of the failure surface

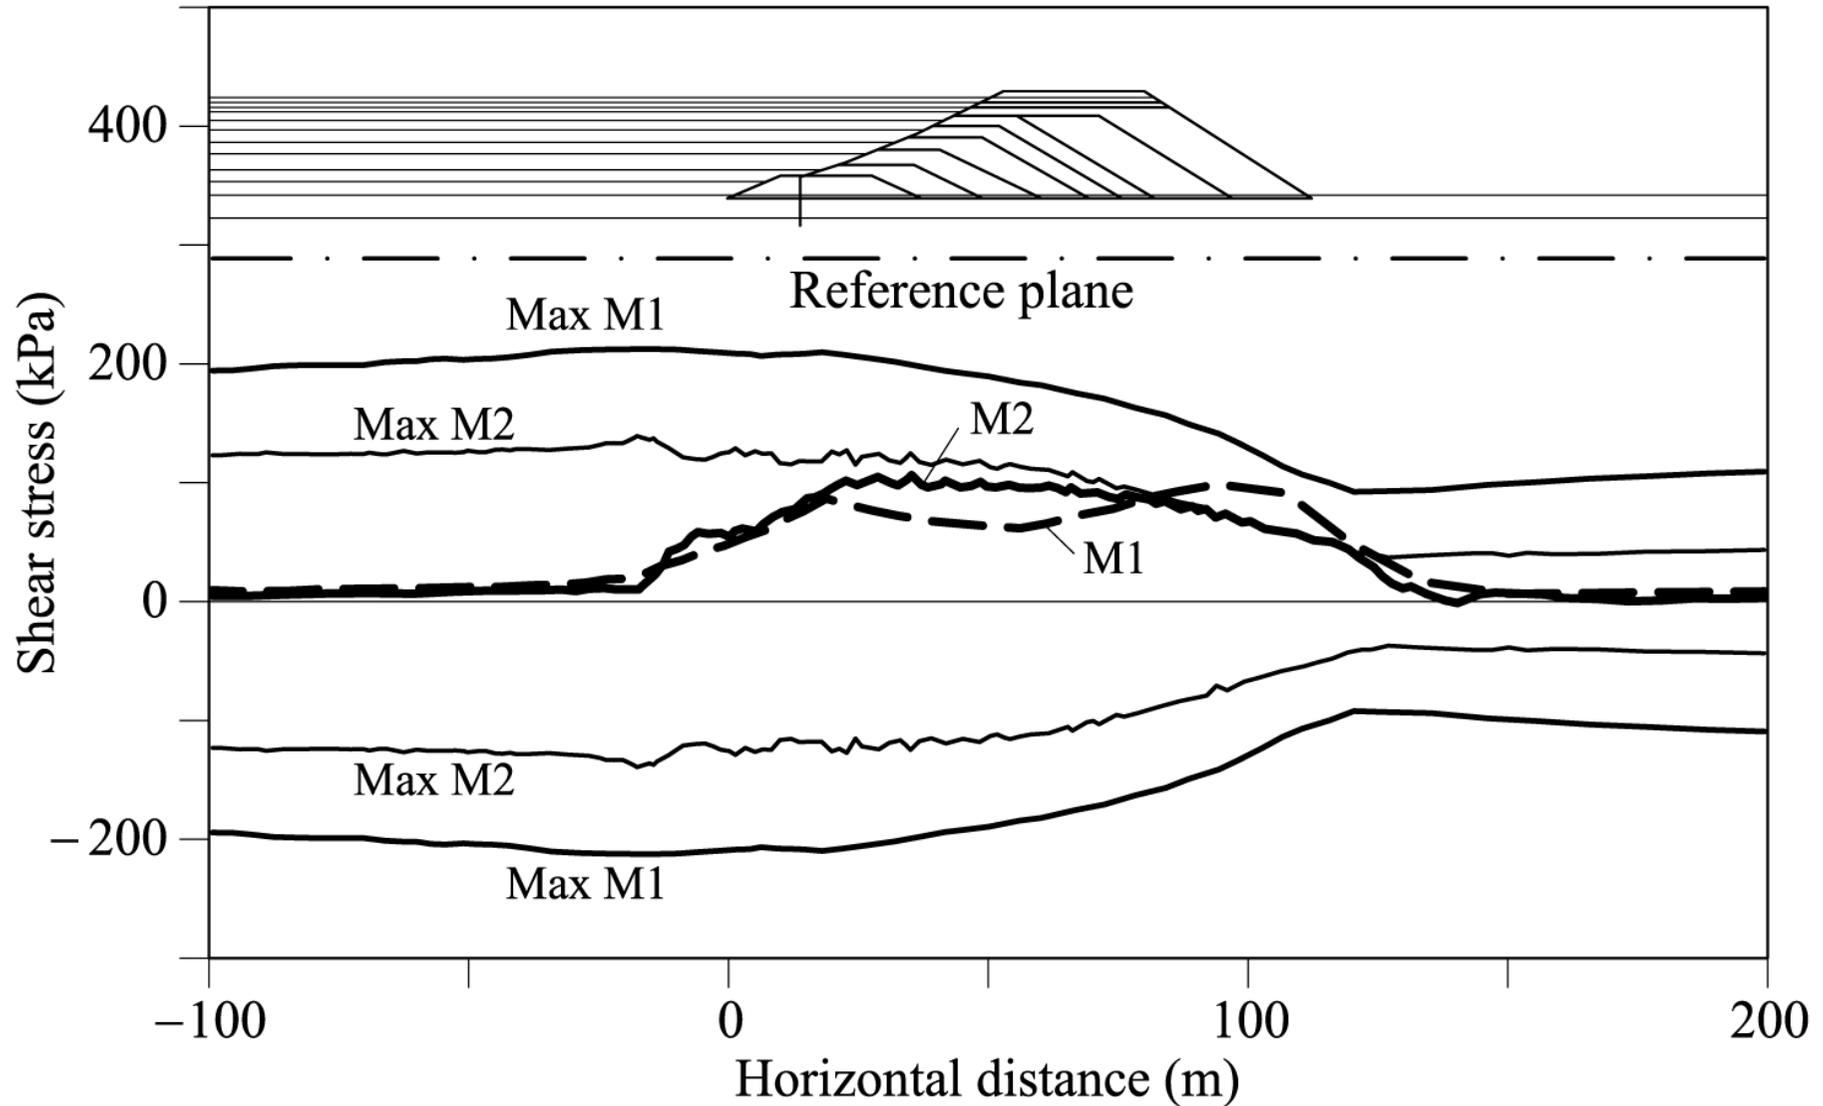
Distribution of shear stresses on a horizontal plane located 10 m below the upper surface of blue clay

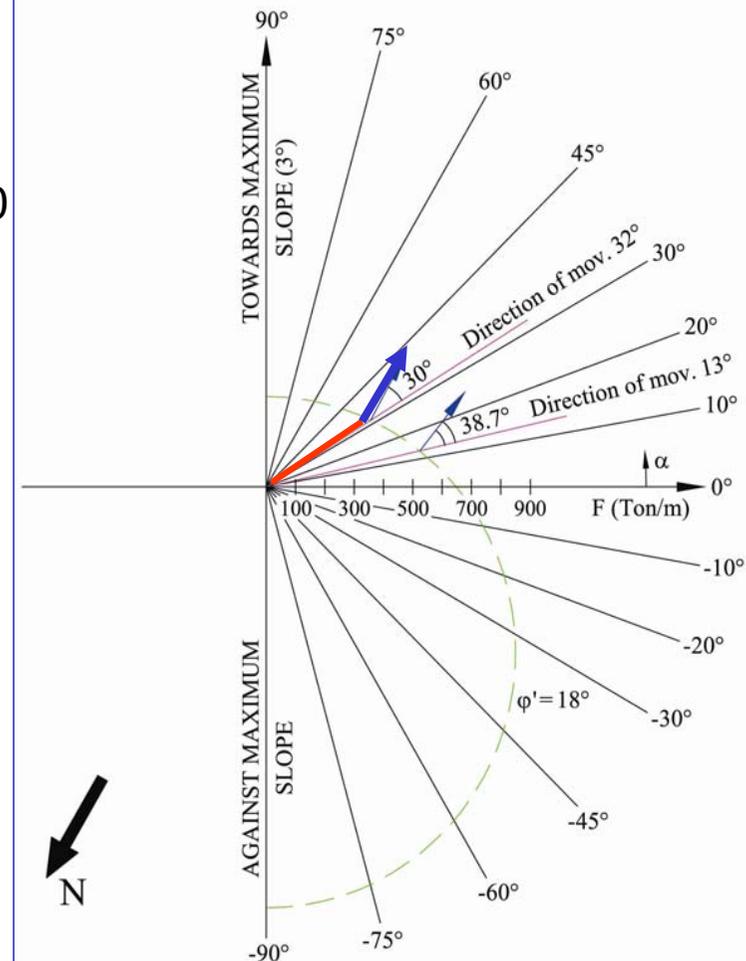
Unstabilizing force (tailings thrust) and motion direction

- NOTE that motion direction is different from thrust direction (consistent with “in situ” observations)

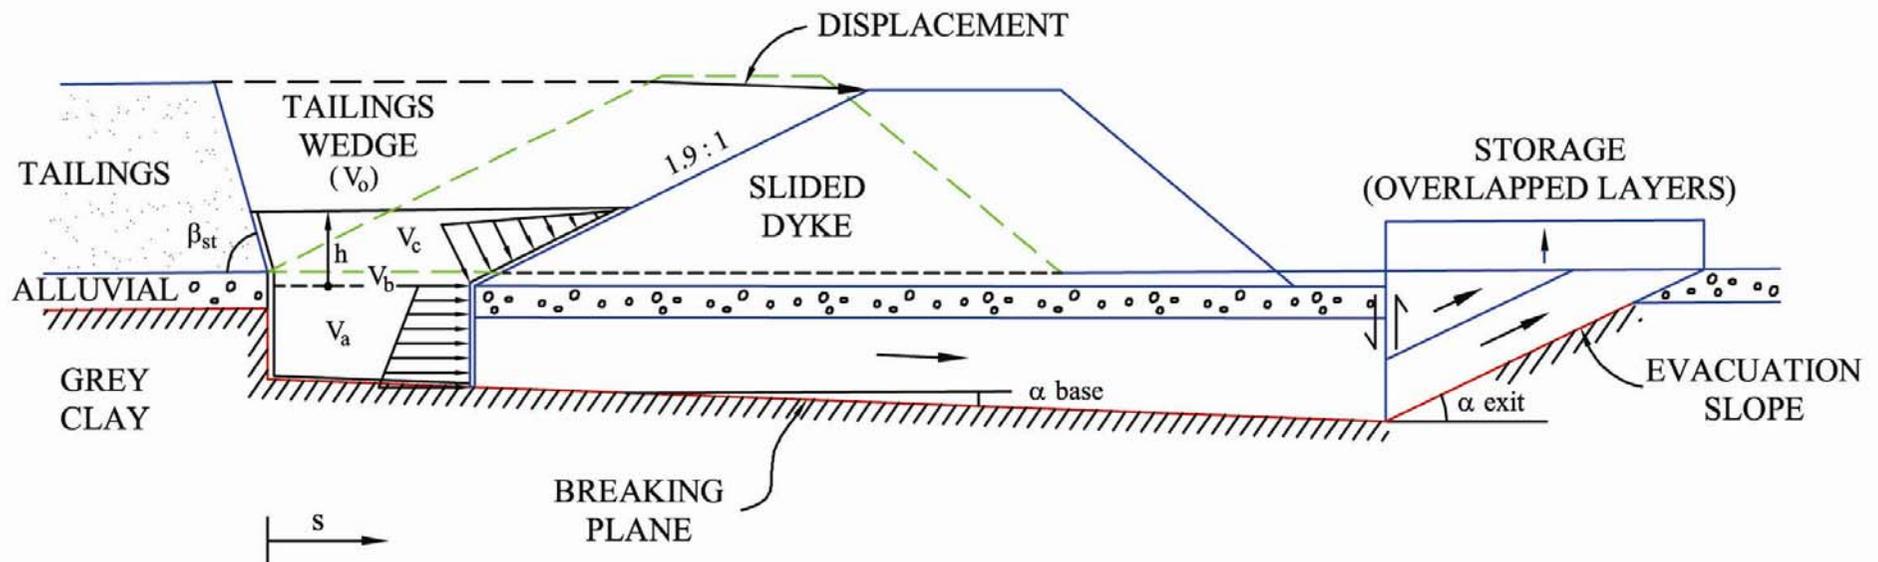
- The solid rigid motion of the dyke provides an opportunity for a simple analysis
- The total displacement of the dyke (known by field observations) allows calibration of the model
- Unknown aspects (velocity, acceleration) may be derived

Conservation of the volume of liquefied tailings: $V_0 = V_a + V_b + V_c \longrightarrow h = h(s)$

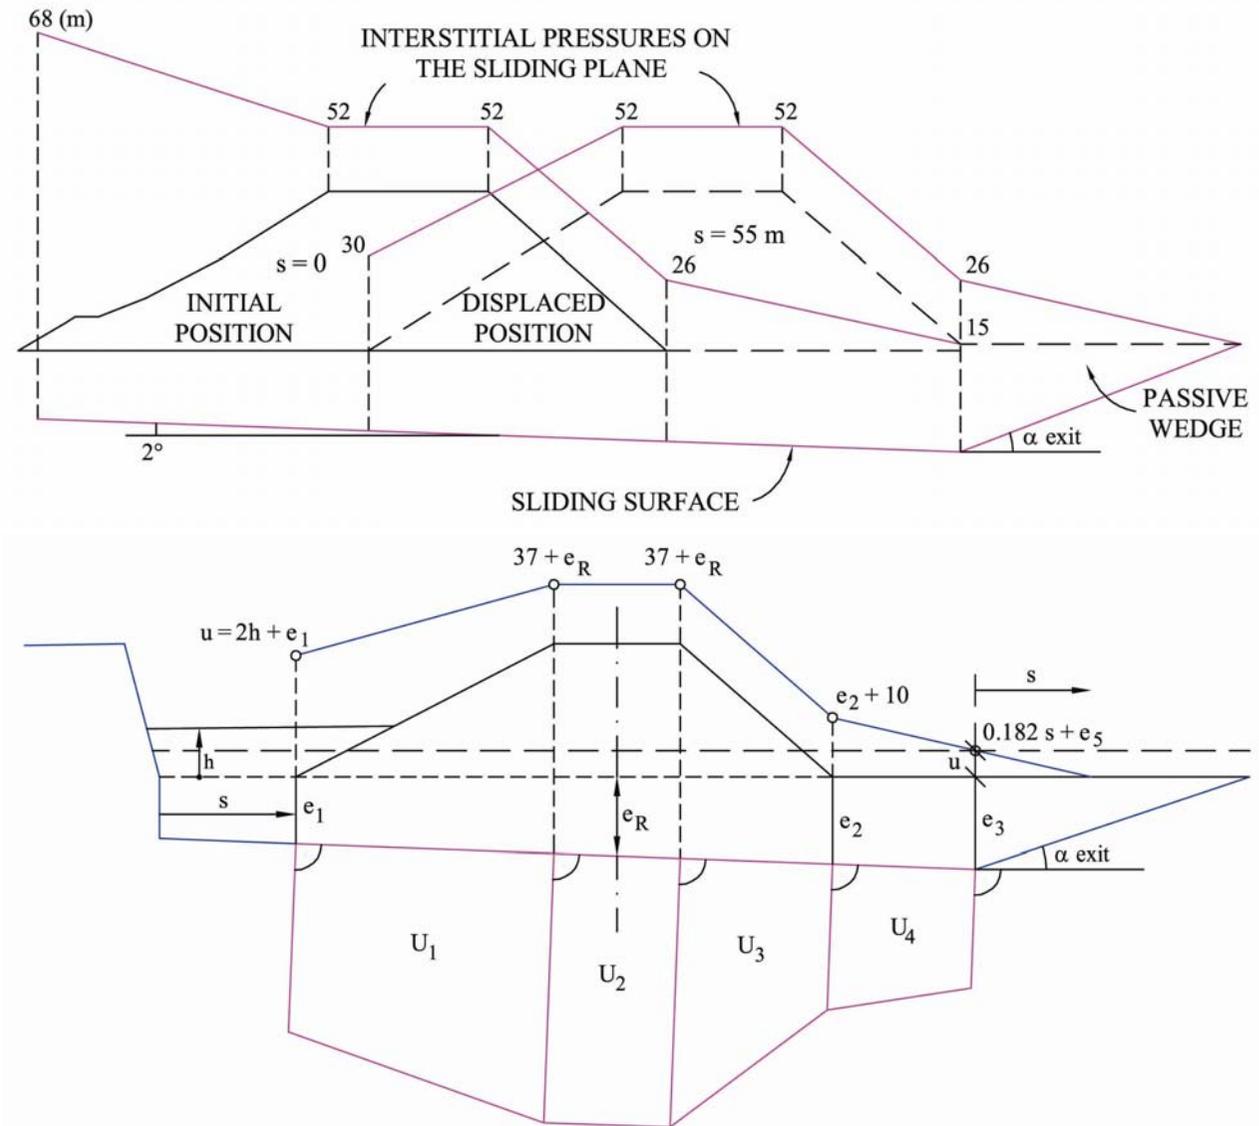
Resistant forces. Pore water pressures

- Rapid displacement of the dyke induces an undrained loading
- Central and downstream parts: Pwp controlled by dyke weight
- Upstream: Pwp controlled by height of tailings

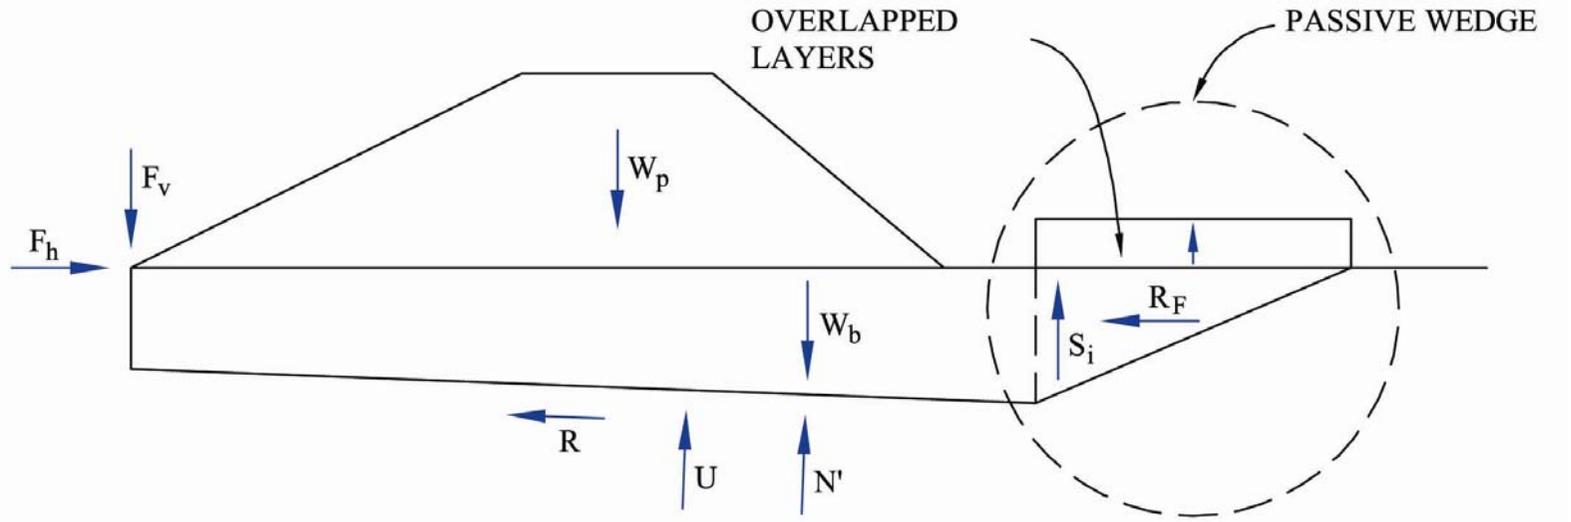
Resistance to sliding. Equilibrium. Basal surface

Equilibrium in vertical direction: $N' = (F_v + W_p + W_b - S_i - U \cos \alpha_b) / (\cos \alpha_b + \sin \alpha_b \tan \phi')$

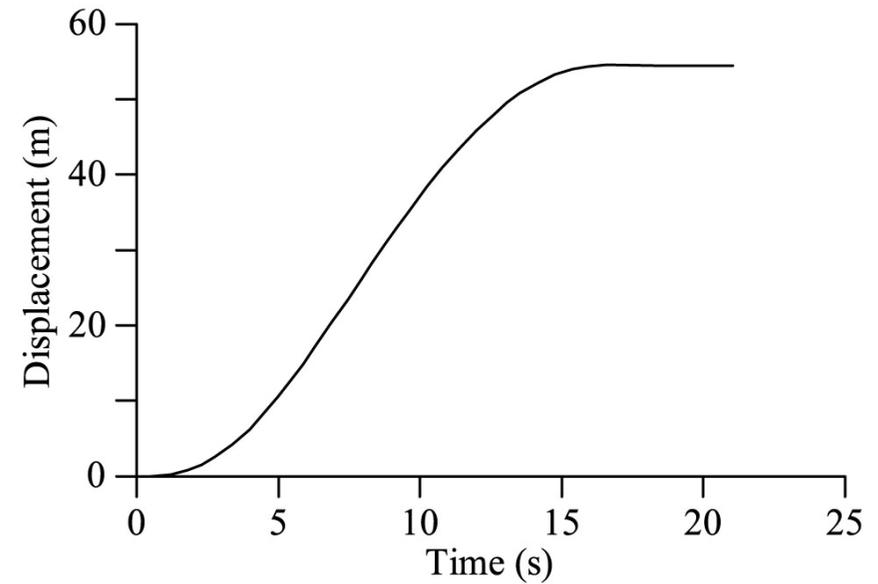
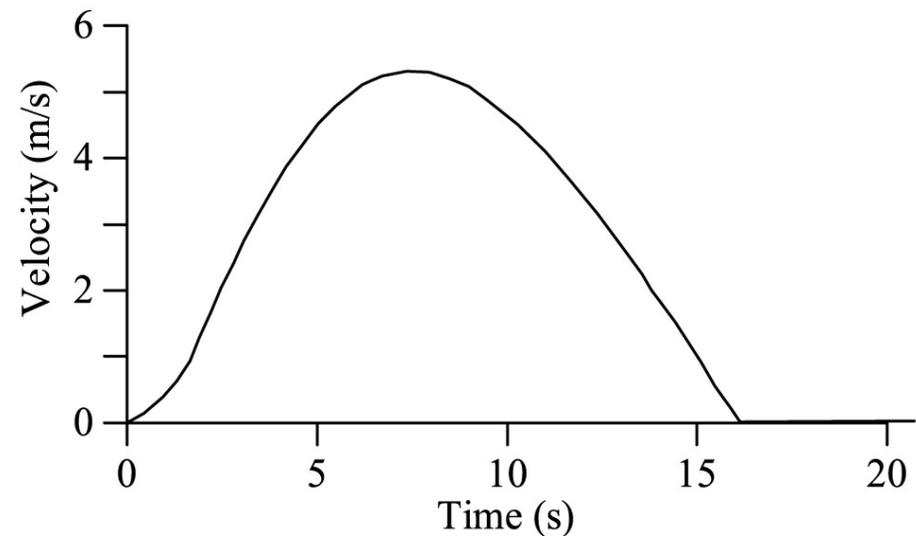
- Time duration of motion: 14.5 s
- Maximum speed: 5.5 m/s (20km/h)
- Maximum acceleration: 0.14g
(Equivalent intensity: 7-8 MKS)

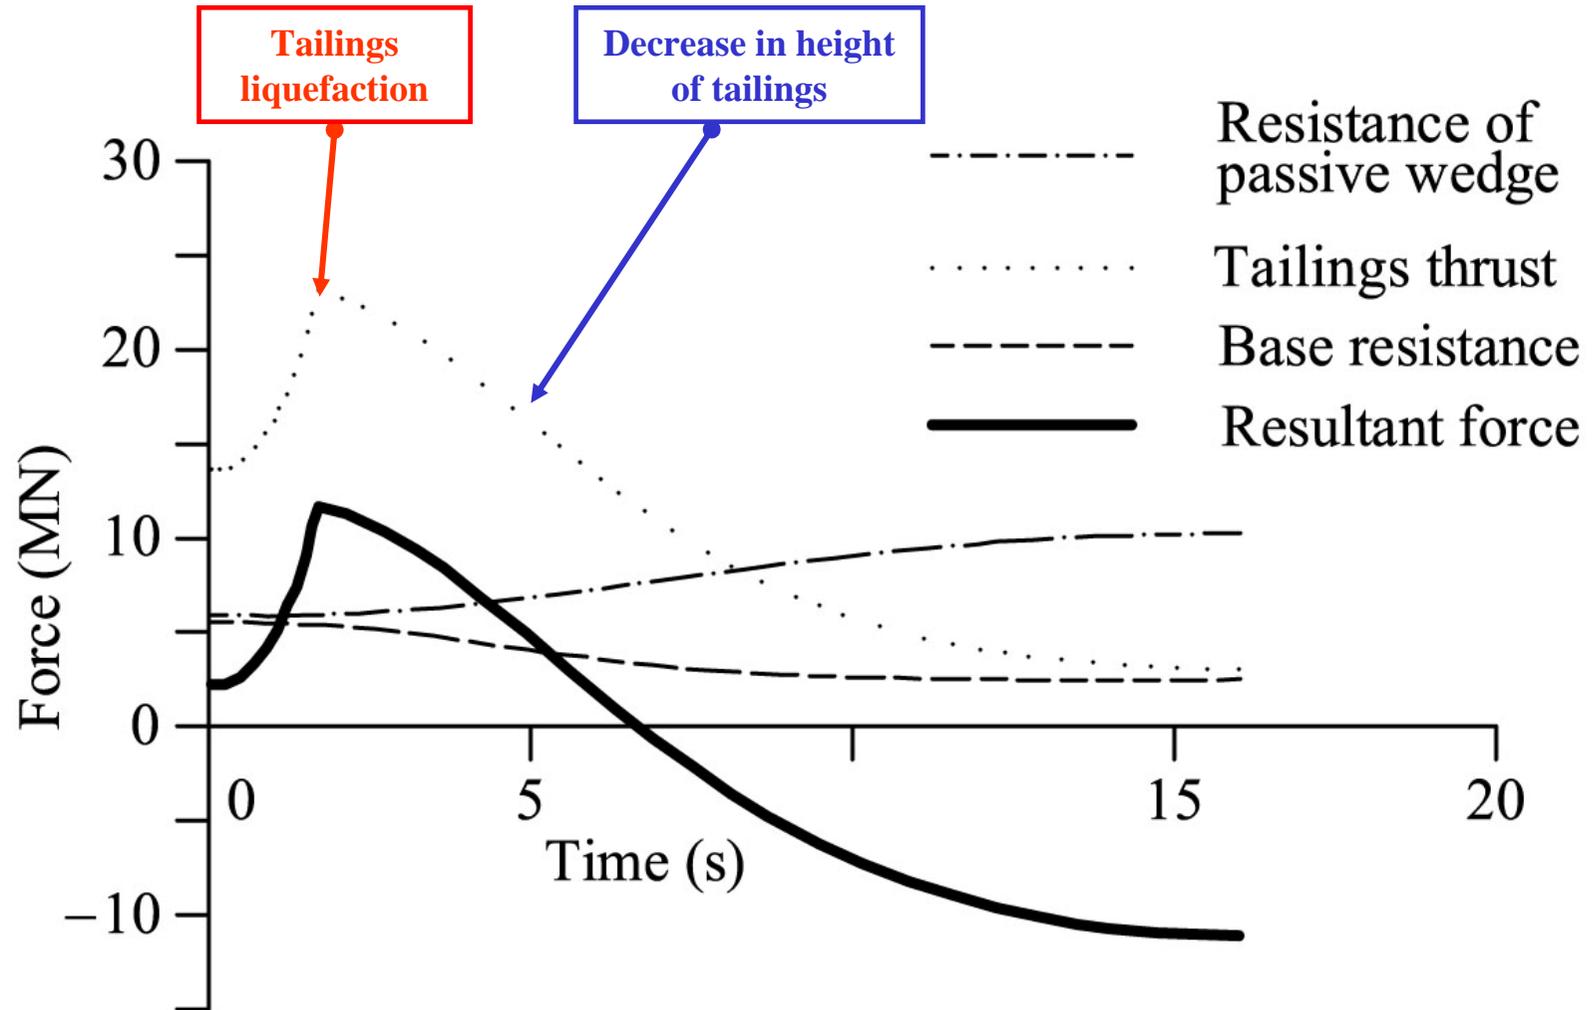
- Summary of forces: Thrust; Base resistance; Passive wedge
